NZ Safety Alert

28 May 2021

Broken link arm on loader

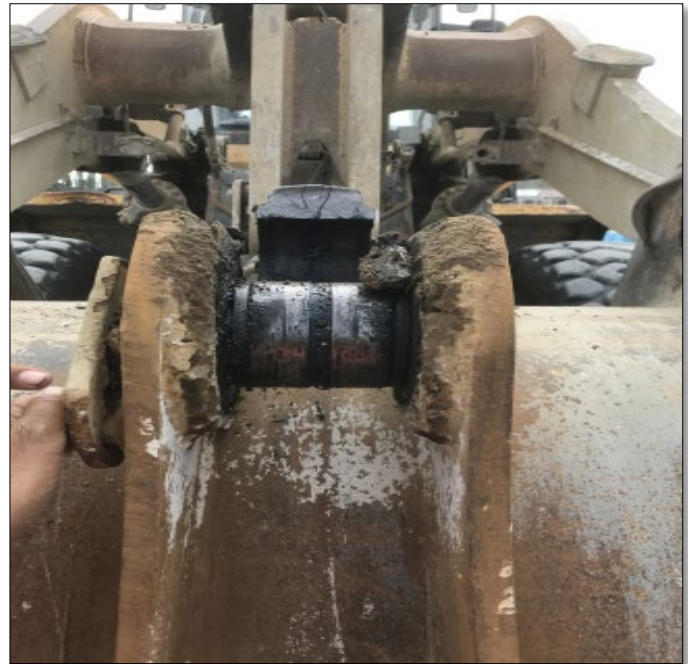
As the loader was lowering the blocks to the ground, the weight released off the lifting chain and the end of the link arm broke off from the crowd pin.

The broken end of the link arm projected into the air before it landed on the ground 9 metres away from the loader.

An engineering inspection found there was excessive wear in the bush, and that the pin that inserts through the link arm was worn causing movement of up to 10mm as the loader bucket rolled backward and forward.

1. Exclusion zones are established for every lift to ensure no-one is in the fall zone or line of fire.
2. Prestart checks on loaders include the link arm and crowding of the bucket to check for excessive movement.
3. Maintenance checks on mobile equipment are conducted in accordance with Original Equipment Manufacturers requirements.
