# **SAFETY ALERT**

## **Stone Mine Massive Pillar Collapses**

Four massive pillar collapses have occurred in limestone mines since October 2020

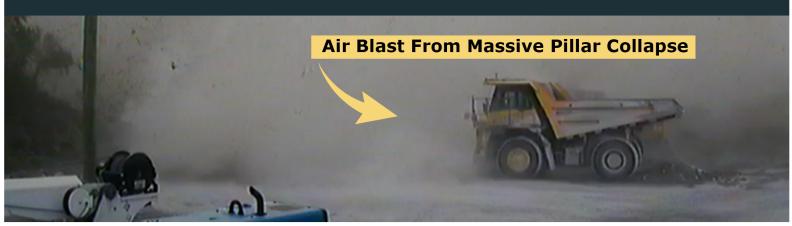
Width-to-Height Ratio Example: 30'/50' = 0.6

- Slender pillars are susceptible to sudden failure
- Benching can create these tall, thin pillars (width-to-height ratio <0.8)</li>
- Collapses can occur in old and recently benched areas

Be Alert for Spalling and Hourglassing

- Properly design pillars for benching (width-to-height ratio >0.8 and assess pillar stability)
- · Maintain planned dimensions
- Account for pillar raveling or blasting overbreak
- · Assess geologic features in the pillar
