# NZ Safety Alert

22 October 2021

## Broken link arm on loader

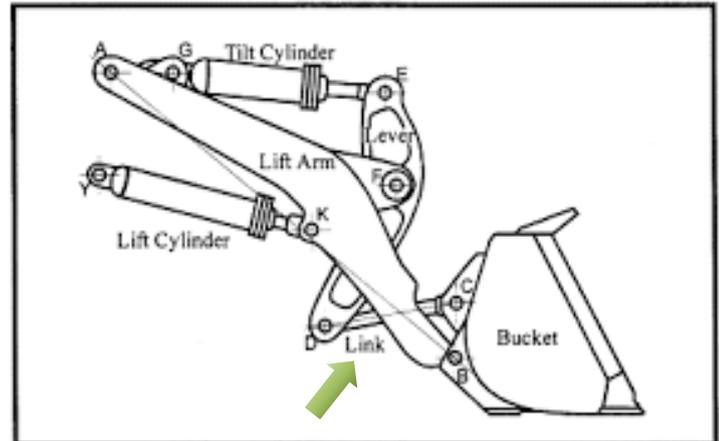
A loader was lifting blocks and stacking them to one side ready to load onto transporter. As the blocks were lowered onto the ground, the end of the link arm broke off.

The broken end of the link arm projected into the air before it landed on the ground 9 metres away from the loader.

Inspection of the link arm found excessive wear in the bush and pin that inserts through the link arm.

The weight of the blocks was well within the lifting capacity of the loader bucket.

1. Daily prestart checks on loaders include inspection of the link arm. Make sure to crowd the bucket to check for excessive movement.
2. When lifting, the appropriate lifting equipment is used and inspected prior to use.
3. No-one is within the fall zone of any lift while the item is being lifted.
4. All mobile equipment is maintained in accordance with Original Equipment Manufacturer requirements.
