## NZ Safety Alert

27 May 2022

## Failure to lock out vehicle

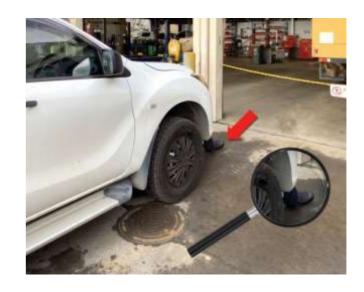
Upon returning to his workbench, the apprentice observed that he hadn't refitted the bash plate. He went out to the forecourt and proceeded to fit the bash plate, getting under the front of the Ute and bolting the plate into place.

The Ute was not locked out, or fundamentally stable and the keys were still in the ignition, putting the apprentice in extreme danger.

- 1. When working on vehicles, the keys are removed, the vehicle is fundamentally stable, and a lockout tag or steering wheel cover are used to indicate that the vehicle must not be moved.
- 2. All workers are trained and competent in the site lockout/tagout system.
- 3. Adequate supervision is available to ensure tasks are conducted safely.
