NZ Safety Alert

4 November 2022

Injury from bench top buffer

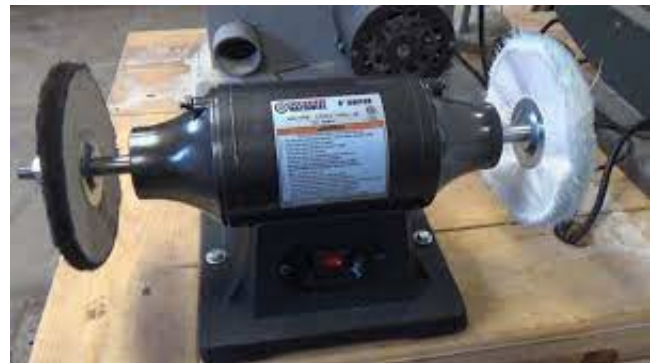
A worker was buffing a bolt on the bench wire wheel when the bolt got jammed by the tool rest and the bolt ended up spinning downwards toward his leg.

The worker was wearing overalls and boots which helped protect him from serious injury but sustained minor bruising to his leg. First aid was administered on site.

1. Appropriate Personal Protective Equipment (PPE) is readily available to all workers when required.
2. Appropriate guards and/or interlocks are installed and maintained on plant to protect workers from moving parts.
3. All workers are trained and assessed as competent to operate all equipment, including workshop tools and machinery.
