# NZ Safety Alert

30 June 2023

## Conveyor on angle

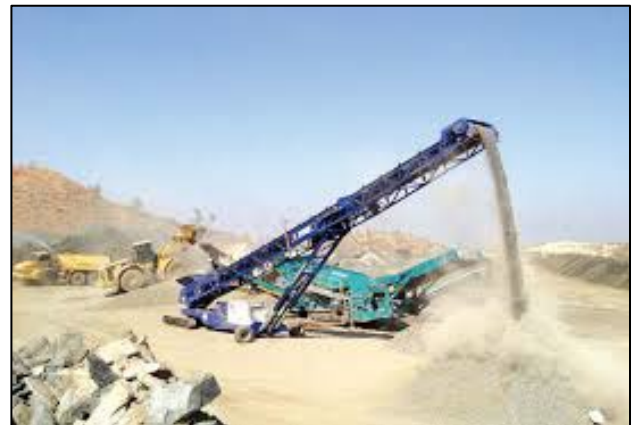
A plant operator noticed a standalone conveyor appeared to be on an angle. As he drove towards the conveyor to investigate further the conveyor had tipped onto its side.

Due to maintenance on a crusher earlier on, workers had to move the standalone conveyor out of the way to complete this maintenance.

When the workers put the conveyor back into place, they put it on top of dust that had accumulated on the ground, making the conveyor unlevel and unstable.

Pieces of steel were used to level up the footing of the legs.

1. All mobile plant is stable and sitting on level ground, particularly after it has been moved.
2. Mobile equipment is maintained in accordance with Original Equipment Manufacturer (OEM) requirements, including legs and stabilising equipment.
3. Workplace inspections are conducted regularly covering all operating plant and activities.
