NZ Safety Alert

24 March 2023

Raised loader bucket incidents

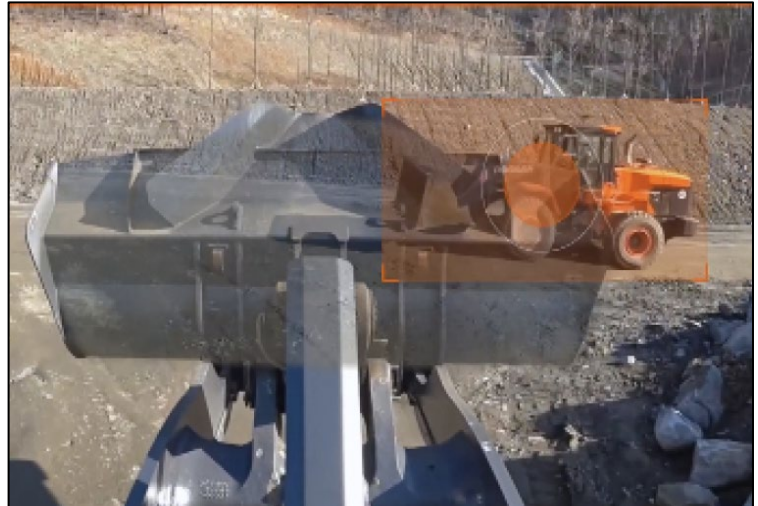
A loader was travelling toward the crushing plant with the bucket lifted. It was turning to head into a bin when it hit a concrete block, breaking a grease line on the boom.

There have been a number of recent incidents where a lifted loader bucket has affected operator visibility.

1. Loader buckets are not lifted when the loader is travelling or prior to trucks entering the loading zone, to ensure clear visibility is maintained.
2. All mobile plant operators are trained and assessed as competent to operate individual pieces of mobile equipment.
3. Suitable clear access is available for mobile plant around fixed plant, including bins.
