NZ Safety Alert

2 June 2023

Tyre blows out on loader

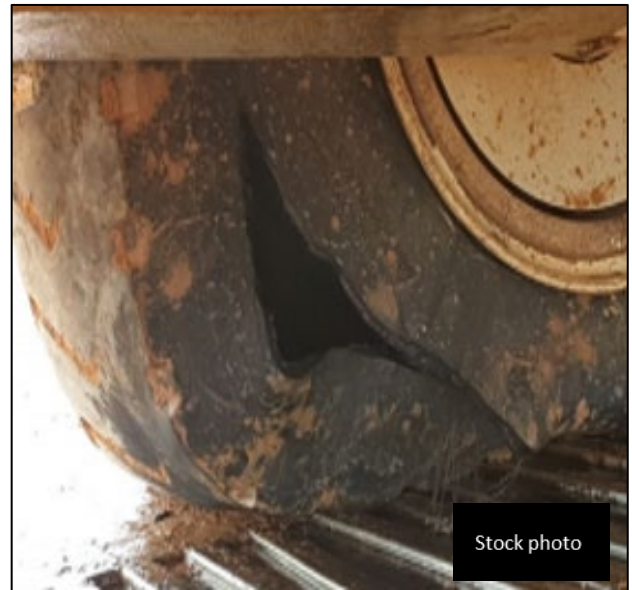
A loader operator was about to tip out a bucket of pit run when the sidewall of the front right tyre blew out.

The operator had slowed the loader down to turn and raise the bucket, and the bucket was near the ground when the tyre blew, which possibly reduced the potential for tipping.

1. Pre-start inspections are conducted on all mobile plant including checks of tyres for damage and wear.
2. Operators of mobile plant are trained and assessed as competent to operate plant including conducting pre-start checks.
3. All mobile equipment is maintained in accordance with Original Equipment Manufacturer (OEM) requirements.
