Welded flange failure on SMBS pump

Mines safety alert no. 363 | 27 March 2019 | Version 1

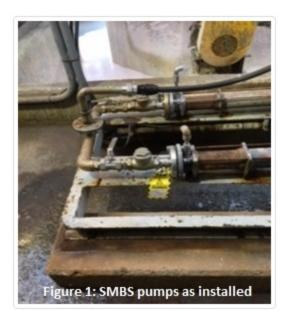
The discharge flange formed a crack that failed, spraying SMBS mist on the worker.

- · The pumps were not bolted or otherwise secured to reduce vibrations or other movement (Critical control)
- · The original installation had threaded the pipe reducing the wall thickness
- The crack appeared to be in the heat affected zone from the weld
- No maintenance or checks of the pipe integrity had been conducted
- No consideration had been given to fatigue and vibration on the pump and infrastructure

- equipment is designed for the intended use in its intended environment
- maintenance monitoring is conducted at appropriate intervals, and should include static plant such as pipes
- equipment is properly secured and supported to reduce the risk of long term fatigue failures due to vibrations
 or other movement
- any safety devices such as pressure relief valves are tested periodically
- appropriate first aid and emergency facilities are available
