Circumferential failure of lockrings

Mines safety bulletin no. 164 | 31 July 2017 | Version 1

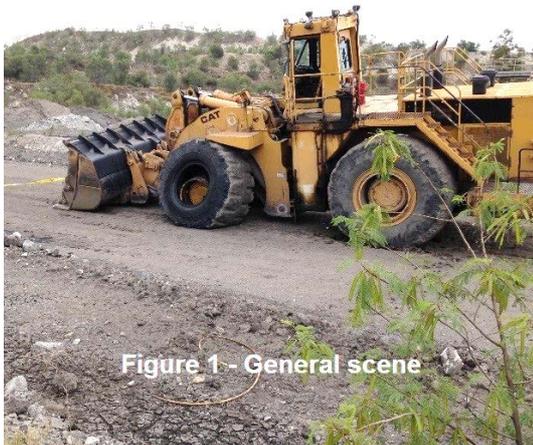
A Caterpillar 992C front end loader left the tyre bay after a new O-ring had been fitted to the position 1 tyre-and-rim assembly. After travelling approximately 100 metres, this same assembly failed catastrophically, resulting in parts being propelled up to 50 metres from the vehicle. No injuries occurred, despite the considerable potential for a serious injury or fatality (see Figures 1 & 2).

Figure 1 - General scene

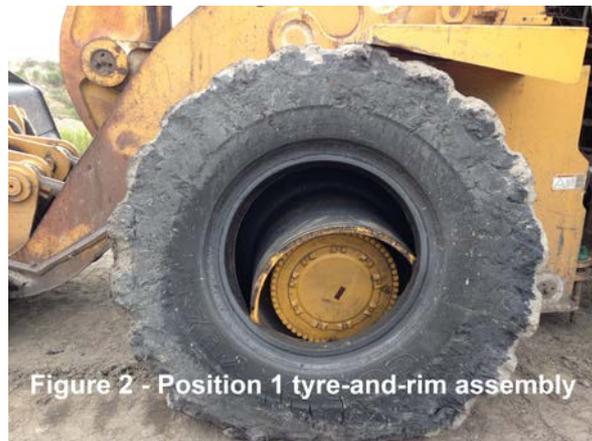
Figure 2 - Position 1 tyre-and-rim assembly

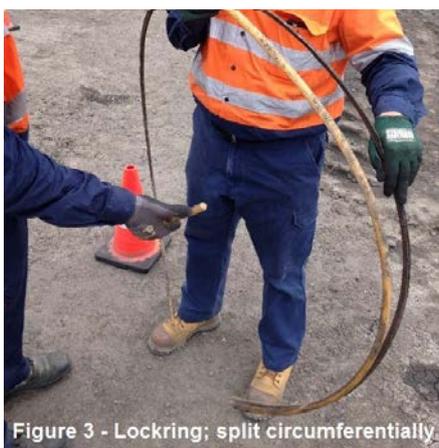
The locking cracked circumferentially through the thinnest section, resulting in two “rings” that were no longer able to keep the assembly together (see Figures 3 & 4).

Figure 3 - Lockring: split circumferentially

- The lockring failed circumferentially through a process of lamellar tearing.
- The lockring contained a large quantity of non-metallic elongated manganese sulphide and other inclusions. These inclusions had a significant detrimental effect on the steel's through-thickness properties.

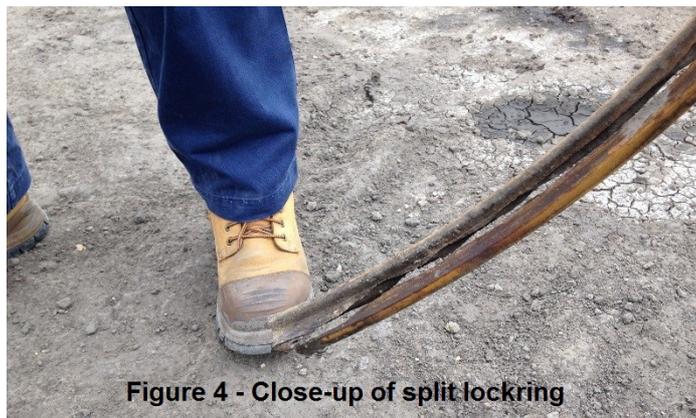
Figure 4 - Close-up of split lockring

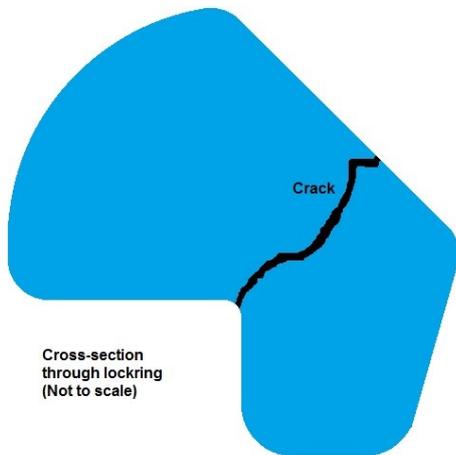
This incident involved a 45" rim with an EM profile lockring. Figures 5 and 6 show the lockring and rim assembly cross-sections.

Figure 5 - Lockring cross-section

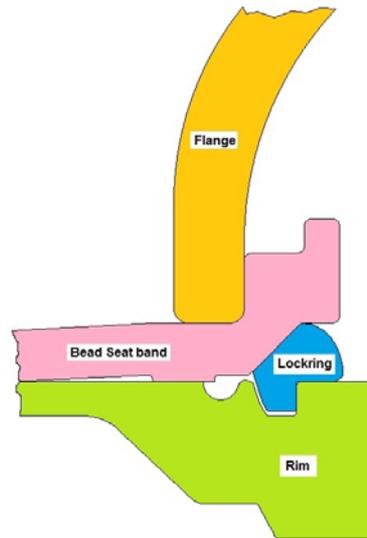
Figure 6 - Cross-section through metal parts of the rim assembly
