# Worker receives flash burns while repairing fuel tank on loader

Mines safety alert no. 367 | 07 August 2019 | Version 1

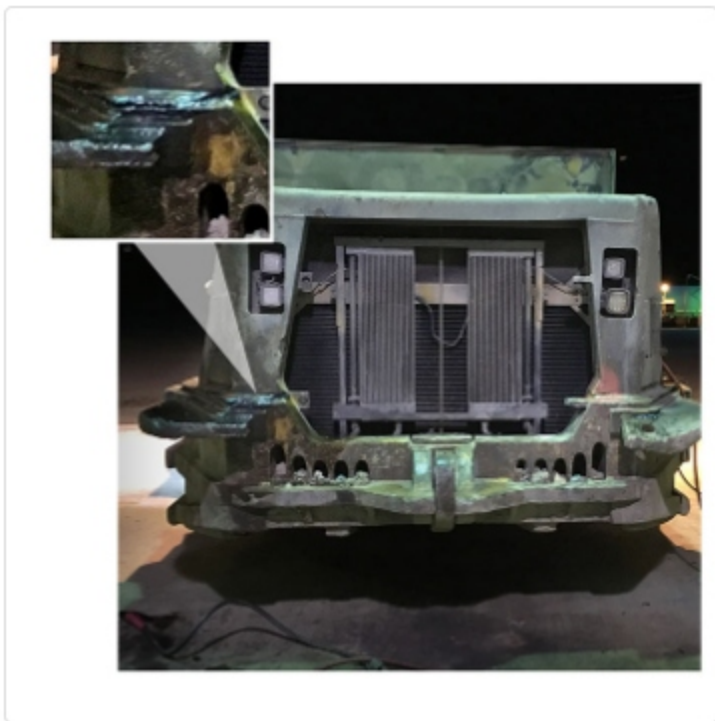
The crack being repaired was on the top of the left hand tank. Nitrogen was introduced into the top of the right hand tank.

In order to speed up the process, the crack was being prepared for welding using an air arc gouging torch, in preference to a grinder. This caused a flash fire in which the worker sustained injuries to their neck and right arm.

The fuel in the left hand tank rose up to be level with the crack due to the uncontrolled introduction of nitrogen in the right hand tank. The fuel, together with the oxygen from the air arc gouging torch created a flammable atmosphere which ignited.

A job safety analysis (JSA) should be developed and adhered to. In this specific situation, the JSA should at least consider the following:

- Ensuring the fuel is at ambient temperature and then isolating the tank that is not under repair.
- Draining the fuel out of the tank that is under repair and using water to flush out any residual fuel. This eliminates the risk of a fire resulting from the tank splitting during the repair work.

- Introducing carbon dioxide (CO<sub>2</sub>) into the top of the tank at an appropriate rate. CO<sub>2</sub> is an inert gas and is heavier than air and will displace any pockets of air. Using CO<sub>2</sub> may require a heated regulator.

- Monitoring the oxygen level inside the tank using a calibrated instrument and when it is less than 3% and stable, grinding or air arc gouging can start.

- Ensuring a second person monitors the oxygen level throughout the repair. Work should stop if the oxygen level rises above 3%.
- Continuing to purge the tank and monitoring the oxygen level after the repair is completed until the tank cools to below the flash point of the fuel before refilling the tank.
