# WEEKLY INCIDENT SUMMARY

Week ending Friday 21 June 2019

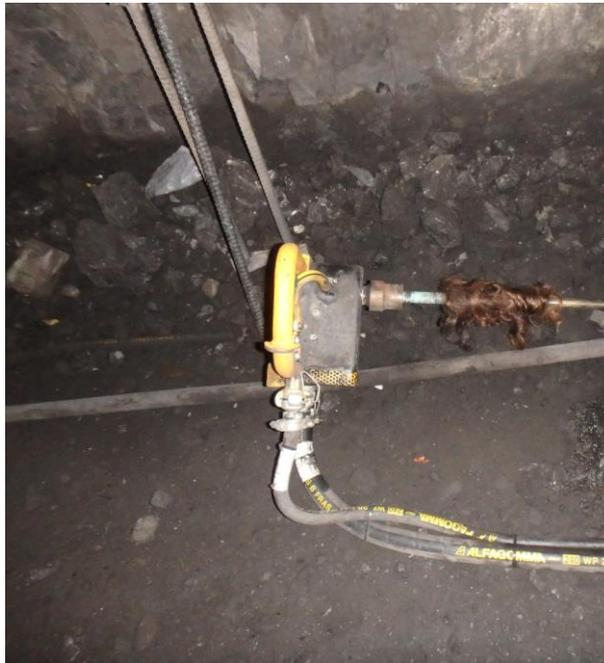
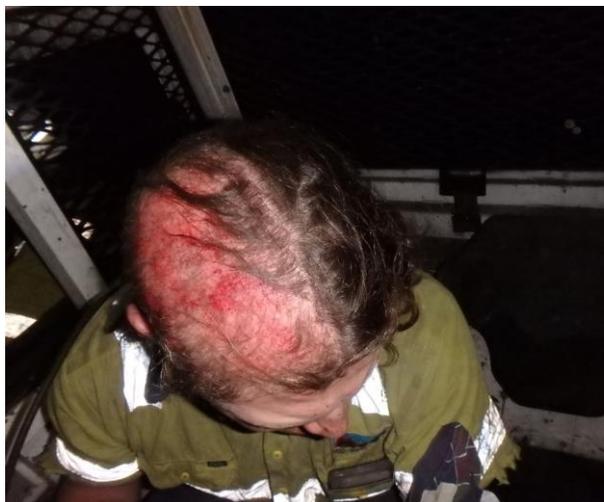
<p>Serious Injury IncNot0034881</p>	<p>A work crew was installing secondary ground support using a handheld boring machine. Two workers were operating the borer. The workers, positioned either side of the machine, were leaning against the borer to apply force. The operator on the left-hand side of the borer lost his footing on wet ground and slipped. This movement caused his hair, which was tied back in a pony-tail, to become entangled with the rotating drill steel. The operator immediately stopped the borer. Hair from the right side of the operator's head was ripped out by the drill steel. The injured operator was assessed by the work group underground and transported to the surface for medical attention. The operator was transferred offsite for further medical attention. The incident site was immediately demarcated as a non-disturbance area.</p>	<p>Mine operators should review the adequacy of their safety management system with regard to managing the risks of entanglement with machinery. Long hair presents an elevated risk if additional controls are not implemented.</p>
