Week ending 1 March 2019

This incident summary provides information on reportable incidents and safety advice for the NSW mining industry. To report an incident to the NSW Resources Regulator: phone 1300 814 609 24 hours a day, 7 days a week.

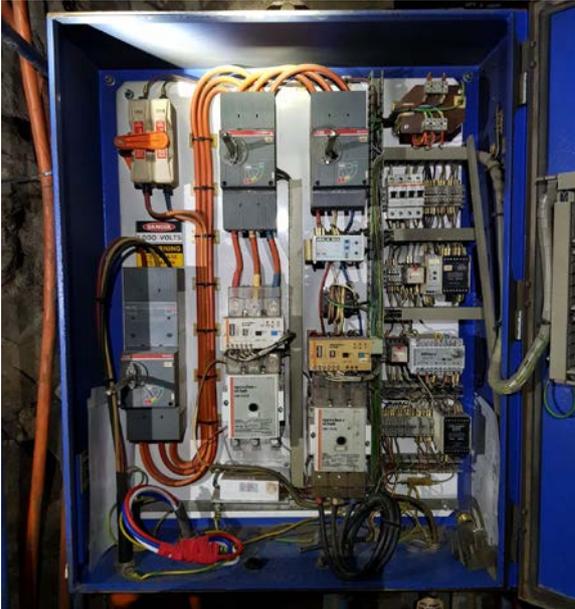
Incident type	Summary	Recommendations to industry
Dangerous incident IncNot0034018	<p>While in the process of reterminating a 1000V outgoing (de-energised) supply cable at a pump starter box, an apprentice electrician has removed the shroud from the live side of the electrical isolator and inserted a T-handle tool to loosen bolts. The apprentice suffered an electric shock. The electrician then pulled the apprentice away and also suffered an electric shock.</p>

<p>Effective supervision of apprentices in the workplace is essential.</p> <p>Isolation points must be determined to sufficiently remove people from energy sources.</p> <p>A S195 prohibition notice and a S191 improvement notice was issued to the mine in relation to this incident.</p>

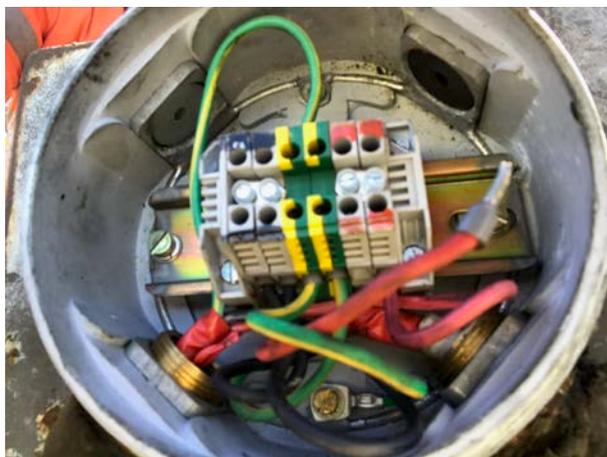
Dangerous incident
IncNot0033965

An electrician suffered an electric shock when working in a junction box. The circuit being worked on was isolated, but another circuit was still energised and the worker contacted the energised conductor.

Before starting work, all potential energy sources must be identified and verified that they have been isolated and tested for dead.
