SAFETY BULLETIN

Workers injured by high pressure fluid

This safety bulletin provides safety advice for the NSW mining industry.

CM9 reference	DOC19/241471
Mine safety reference	SB-19 - 04
Date published	26 March 2019
Authorised by	Chief Inspector Office of the Chief Inspector

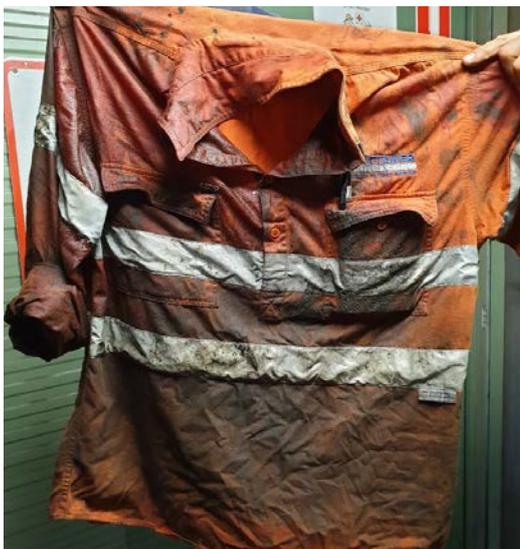
Figure 1: Shirt damaged by high pressure fluid release

During a longwall changeout a contract maintenance worker isolated a roof support and checked the pressure gauge on the maingate leg which appears to have indicated zero pressure. The worker then loosened retaining bolts on the double check valve on the roof support leg. The stored pressure in the support leg released and tore the workers shirt and caused abrasions to his chest.

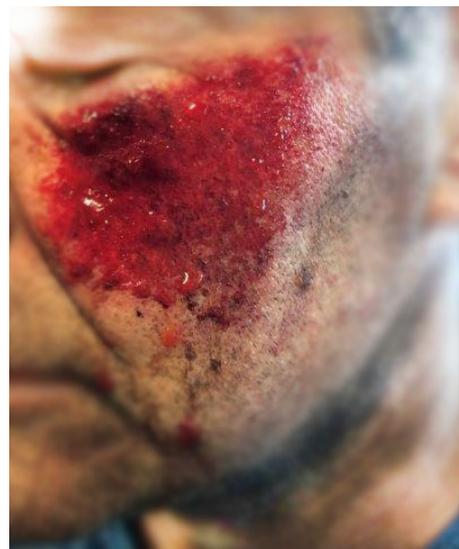
Figure 2: Facial injury caused by high pressure fluid release

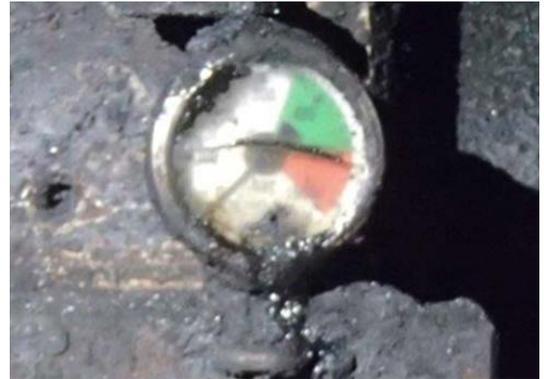
The pressure gauge was later tested as operational; however, the cover was cracked. A face audit identified that three out of 680 pressure gauges on the longwall face were also incorrectly indicating zero pressure.

Figure 3: A pressure gauge on the longwall face

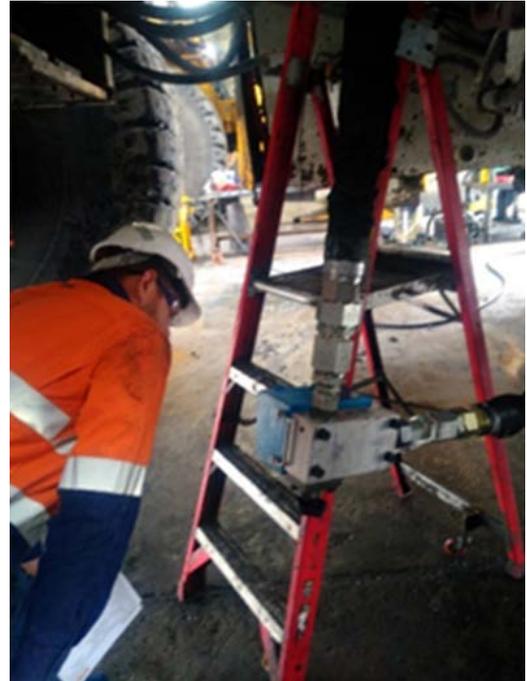
A contract maintenance worker was performing live hydraulic pressure testing to obtain pressure decay data from a hydraulic hoist on a large haul truck. The fitting connecting the hydraulic hose to the test meter released fluid under pressure and the worker was struck in the face by high pressure fluid.

Figure 4: Simulation of the location of the injured person in relation to the hydraulic fittings connecting to the hydraulic pressure testing equipment

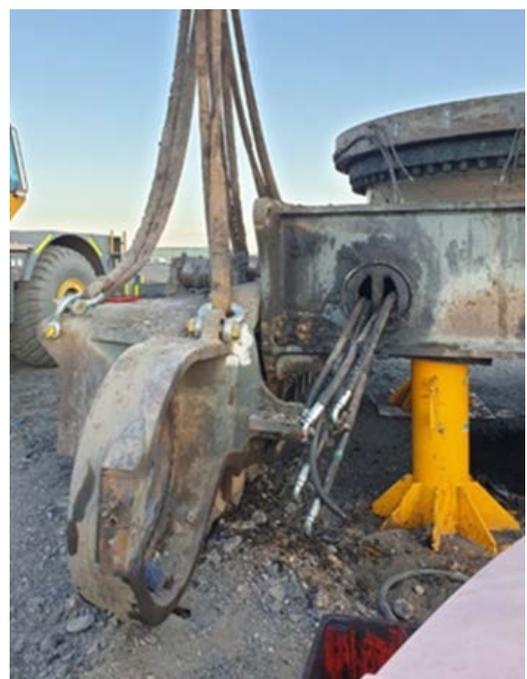
Contract maintenance workers were dis-assembling a large excavator base pod. The confirmation of the isolation undertaken earlier by other workers had failed to identify an accumulator holding stored pressure. Upon disconnecting the hose fitting a worker was struck in the face and body by high pressure fluid.

Figure 5: Disconnected hydraulic lines exiting from the excavator pod. The accumulator is hidden from view inside the base pod

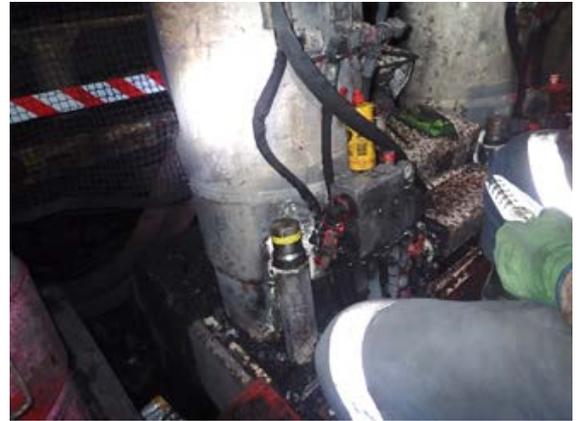
The worker isolated the tailgate side cylinder and attempted to remove the yield valve. The worker left the area and on return went to the non-isolated maingate side cylinder yield valve and attempted to remove the valve. The worker removed a staple on the maingate side valve block and was struck in the face by high pressure fluid.

Figure 6: A worker located adjacent to an exposed hydraulic valve on a cylinder leg

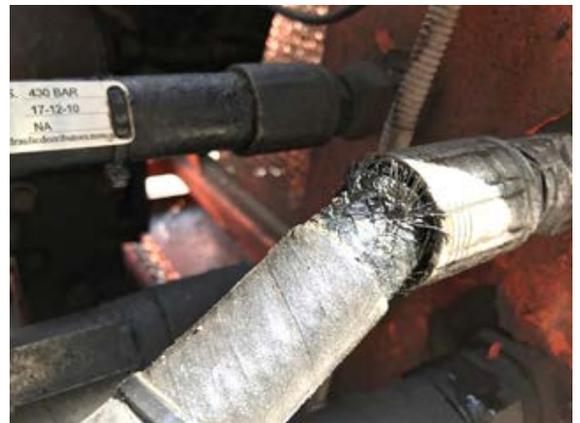
A contract maintenance worker was pre-commissioning a haul truck recovery power pack. The power pack was started without being connected to a host machine or testing equipment. When the worker started the power pack an over-pressurisation occurred, and a hose burst at a fitting. The worker was struck by high pressure fluid.

Figure 7: The failed hydraulic hose on the recovery power pack
