NSW Resources Regulator

INVESTIGATION REPORT

**Report into the serious injury of a mine worker on
1 February 2016 at the Sibelco Salt Ash Sand Plant**

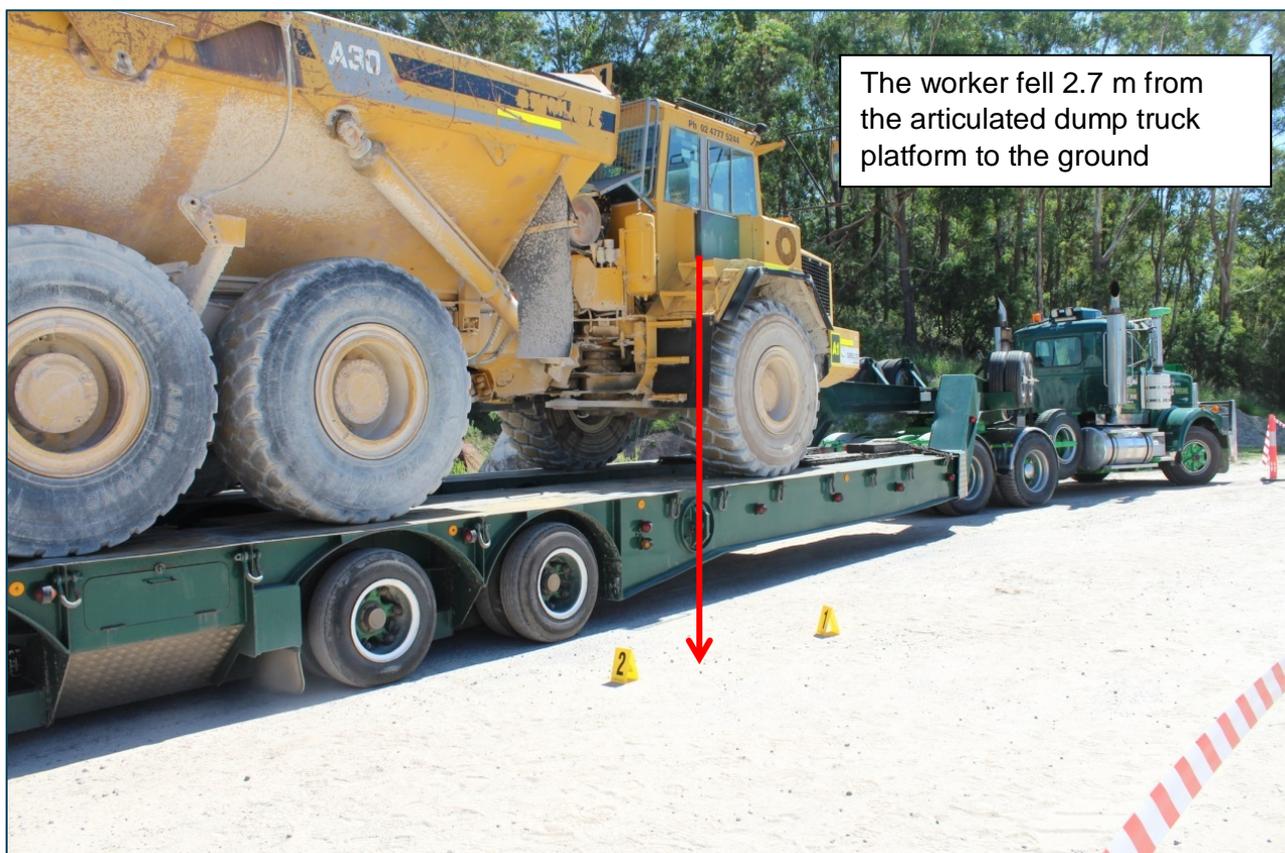
Figure 1: View from the right (off-driver's) side of the Volvo A30 A1 on the low loader truck on 1 February 2016. The two yellow numbered markers indicate the approximate location where the worker fell to the ground.

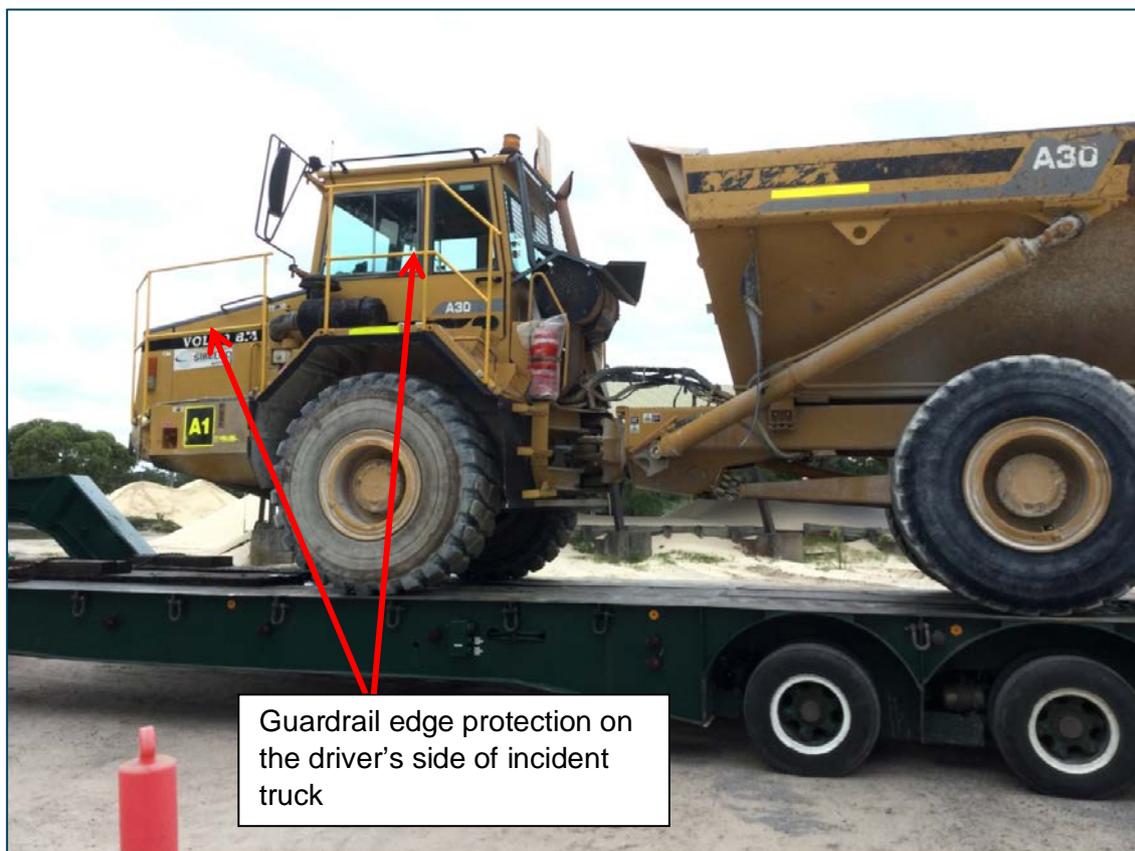
Figure 2: View from the driver's side access of the dump truck on the low loader truck on 1 February 2016.
 Note the two modified light yellow outer guardrails fitted to the walkway access areas on the driver's side of the truck.

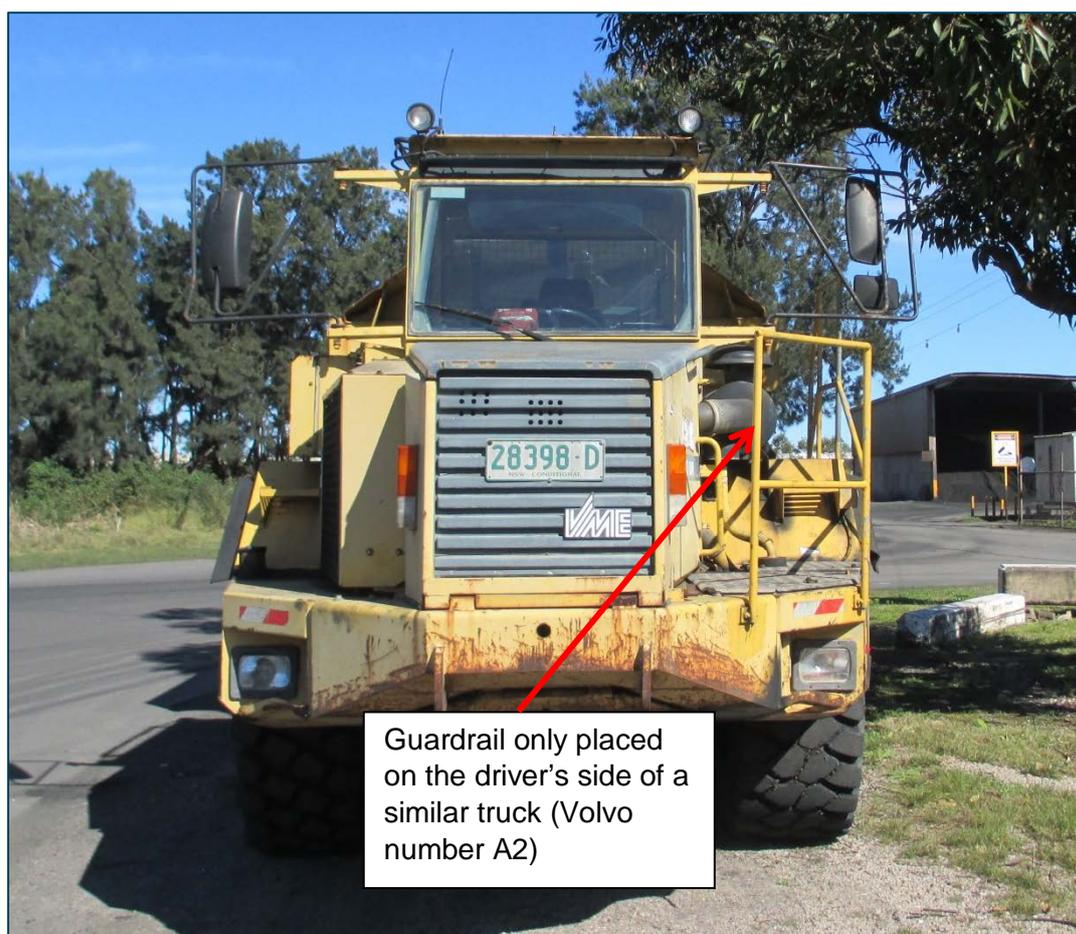
Figure 3: Front view of Volvo A30 number A2 (similar to number A1) at Sibelco processing plant at Sandgate, NSW, on 11 August 2016. Showing the original version created before 2014 of the modified guardrail fitted only to the driver's side platform.

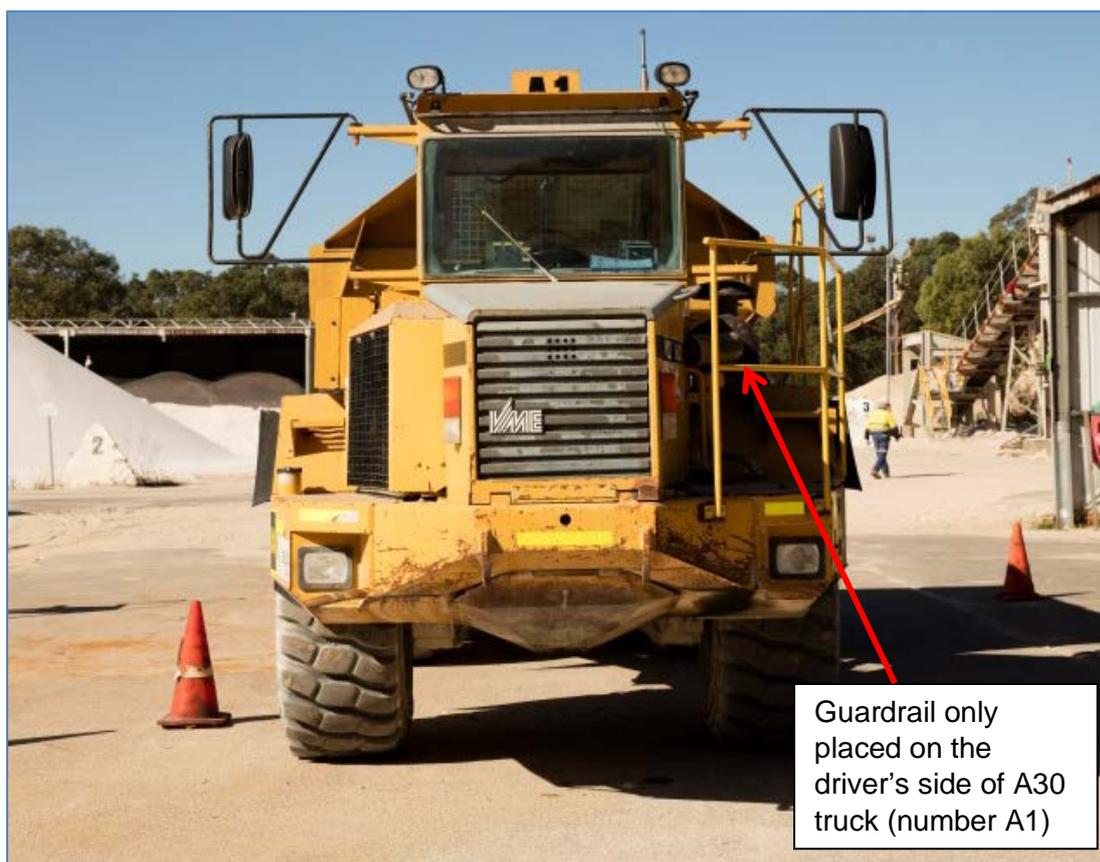
Figure 5: Front view of dump truck at Salt Ash site on 8 May 2016. Showing the modified guardrail fitted only placed on the driver's side platform.

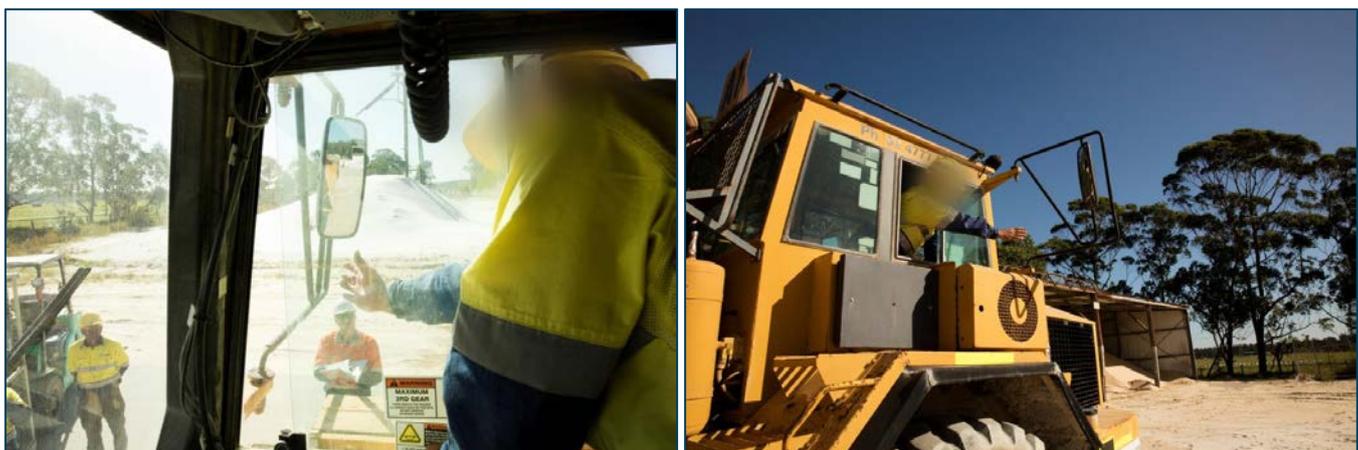
Figure 6: A person leaning outside the cabin window could not reach out to fully open the bracket from inside the cabin.

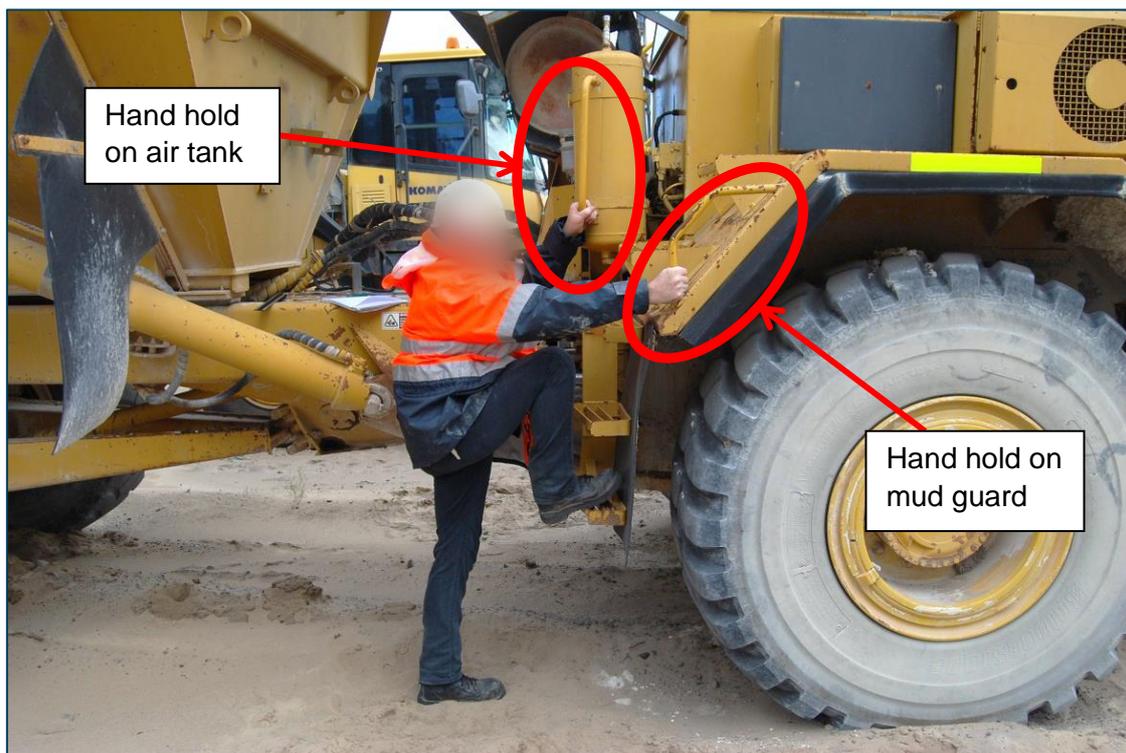
Figure 7: Three points of contact are possible from the ground level using the vertical hand-hold on air tank and hand-hold on the mudguard to enable access the off-side step ladder of the dump truck.

From ground level onto the step ladder it was easy to achieve three points of contact using the hand-hold attached to the air tank for the left hand and the hand hold attached to the truck mud guard for the left hand.

However, three points of contact using the left-hand vertical hand-hold on the air tank and the right-hand inclined hand-hold attached to the mudguard could not be maintained after the first step.

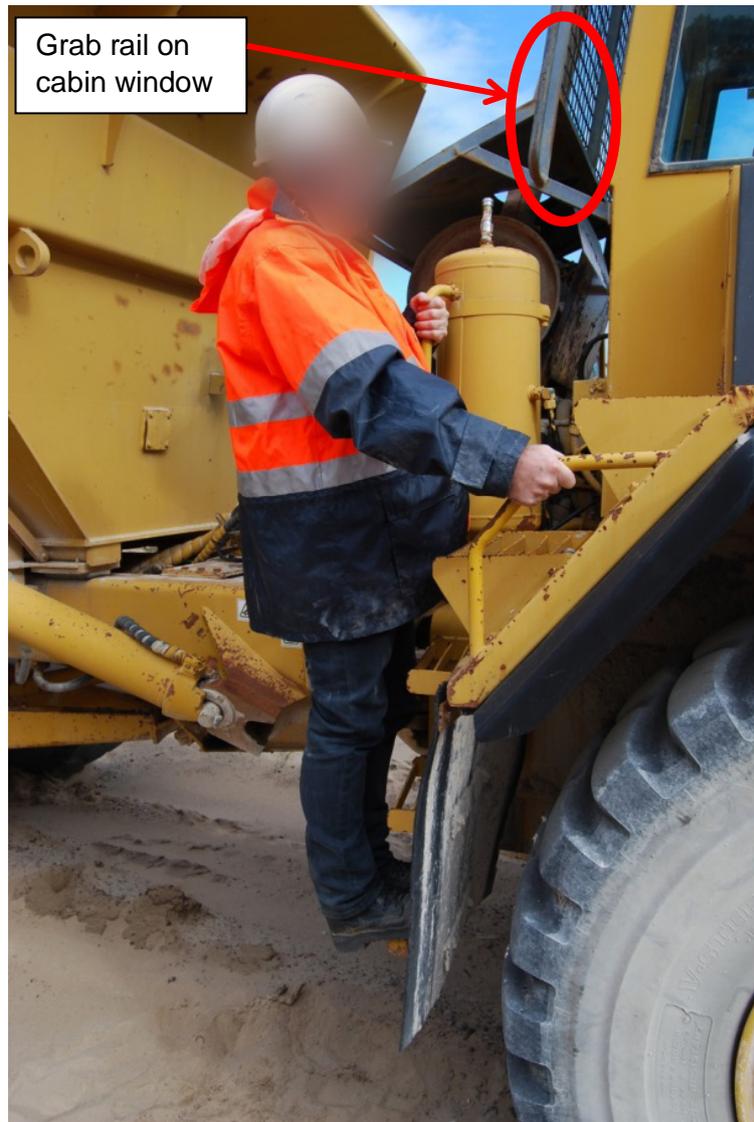
Figure 8: Three points of contact for access onto the first rung of the step ladder.

To move from the upper tread of the step ladder onto the stair required the left hand to move from the hand hold on the air tank onto a near vertical grab rail attached to the rear cabin window guard frame.

The transition onto the stair from the step ladder made three points of contact difficult.

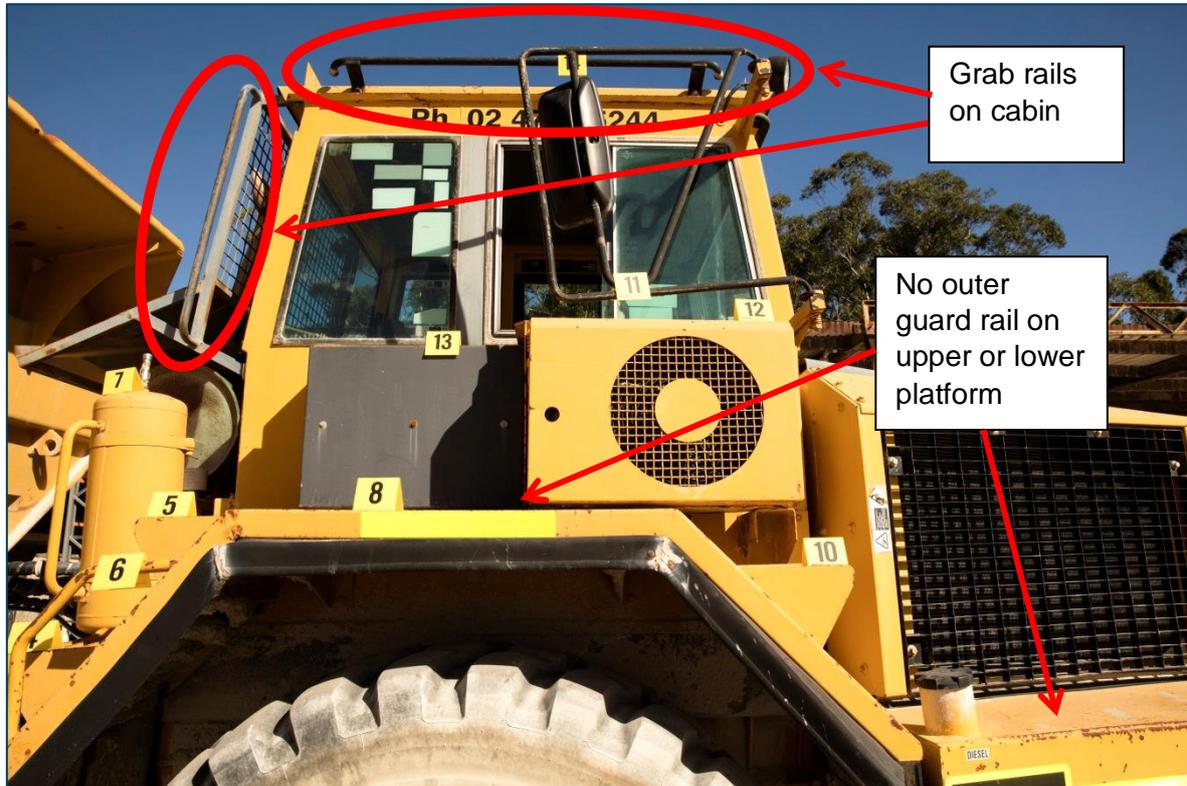
Figure 9: The hand hold and two grab rails on the truck. The vertical hand hold attached to the air tank, the near vertical grab rail attached to the cabin rear window guard frame and the horizontal grab rail attached to the top of the cabin. The photograph shows the wing mirror in a closed position. There is no guardrail on the outer edge of the upper or lower platform.

To move from the top step at position number 5 (as indicated by the yellow markers) onto the platform at position number 8 required a person to use two grab rails, both grab rails were on the same side on the cabin structure.

Using the near vertical grab rail attached to the cabin rear window guard frame would then require hand placement onto the horizontal grab rail attached to the top of the cabin roof. There was no available outer guardrail in this area to enable intuitive three points of contact.

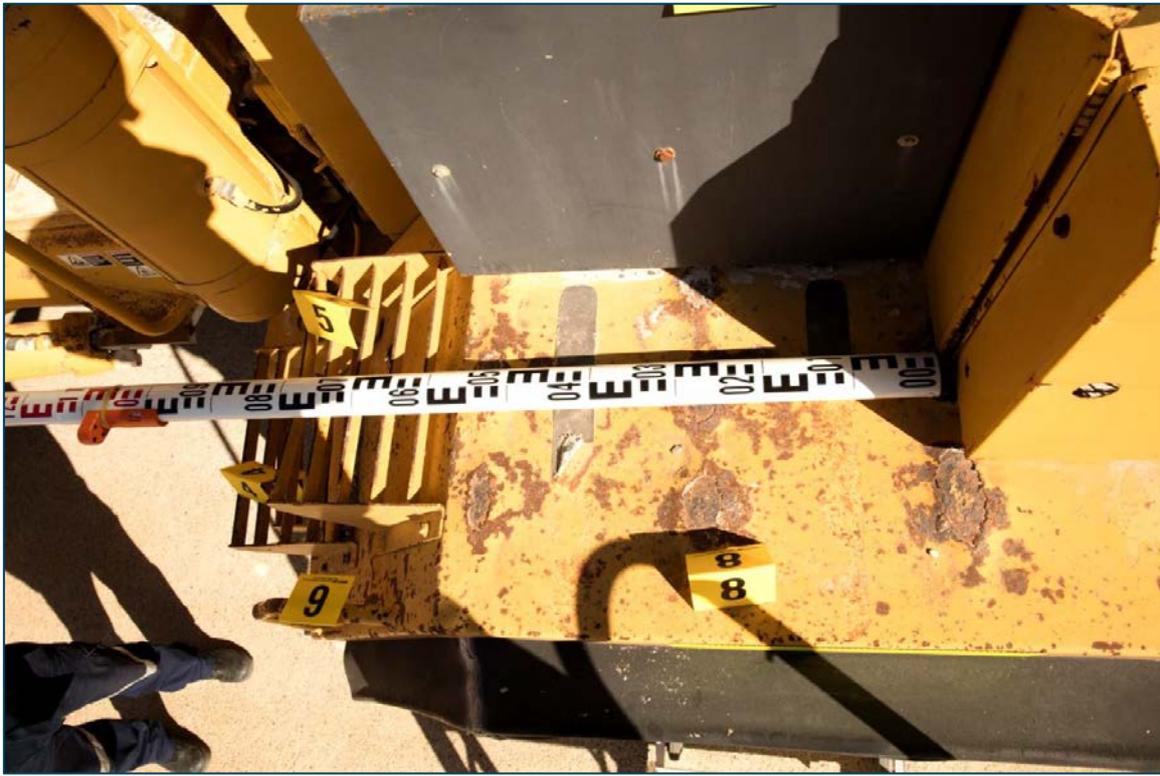
The platform was degraded with an uneven and rusted surface and the slip protection tape strips were worn or missing from the platform.

There was also damage to the outer flat bar welded stringer on the top step.

Figure 10: The degraded condition of the platform (position number 8) leading onto top of the steps (position number 5) visible uneven rusted surface, worn or missing slip protection tape strips on the platform.

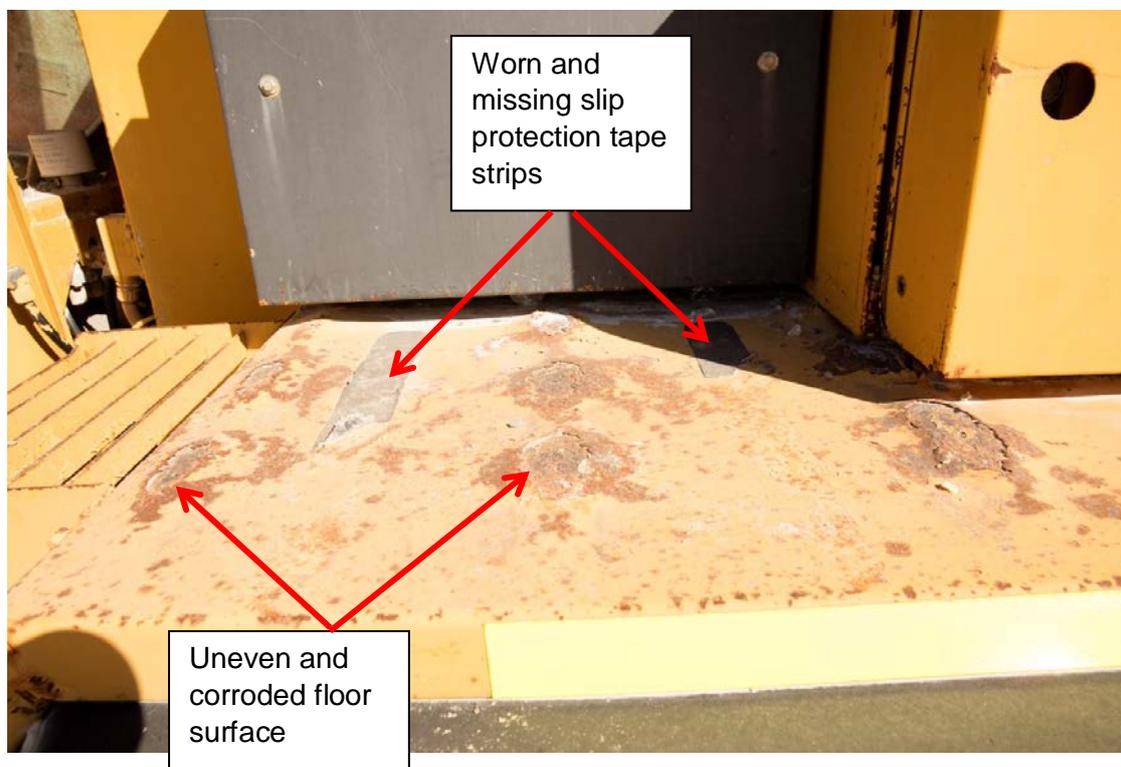
Figure 11: A closer view of the degraded condition of platform (position number 8) leading onto top of steps.

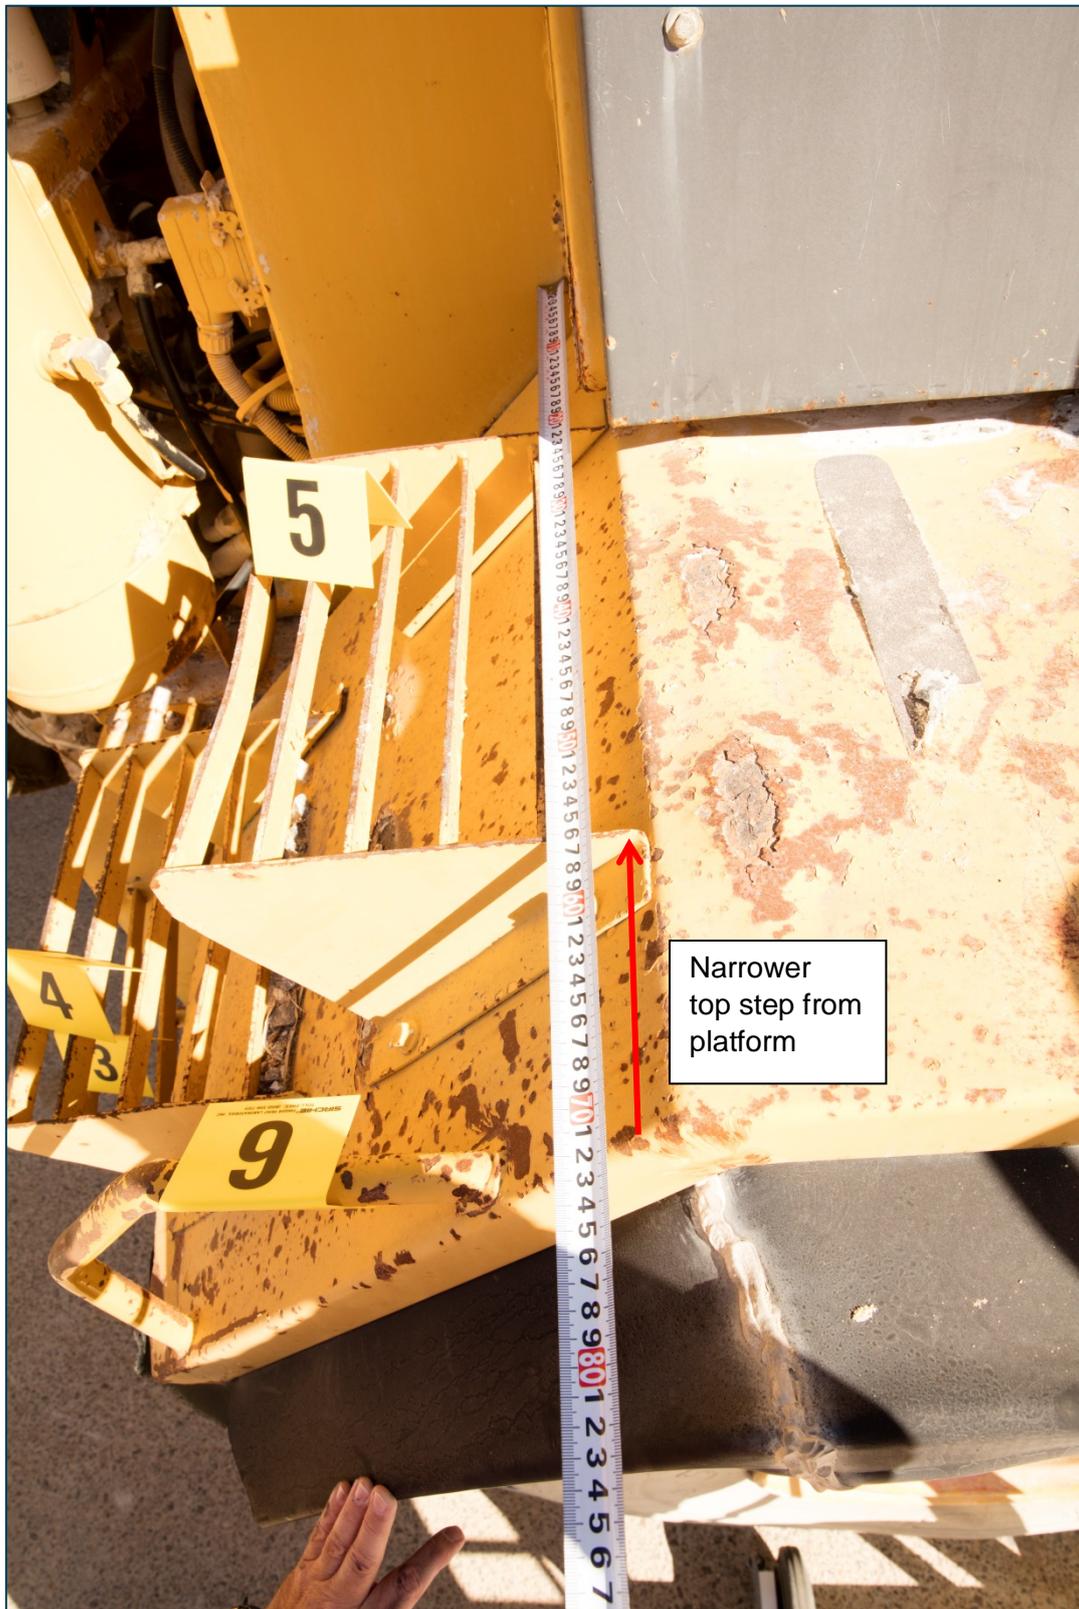
Figure 12: The reduction in width of 160 mm of the top tread of the stair (position number 5) from the platform and the uneven, rusted surface of the platform and worn slip protection tape strip onto the top step.

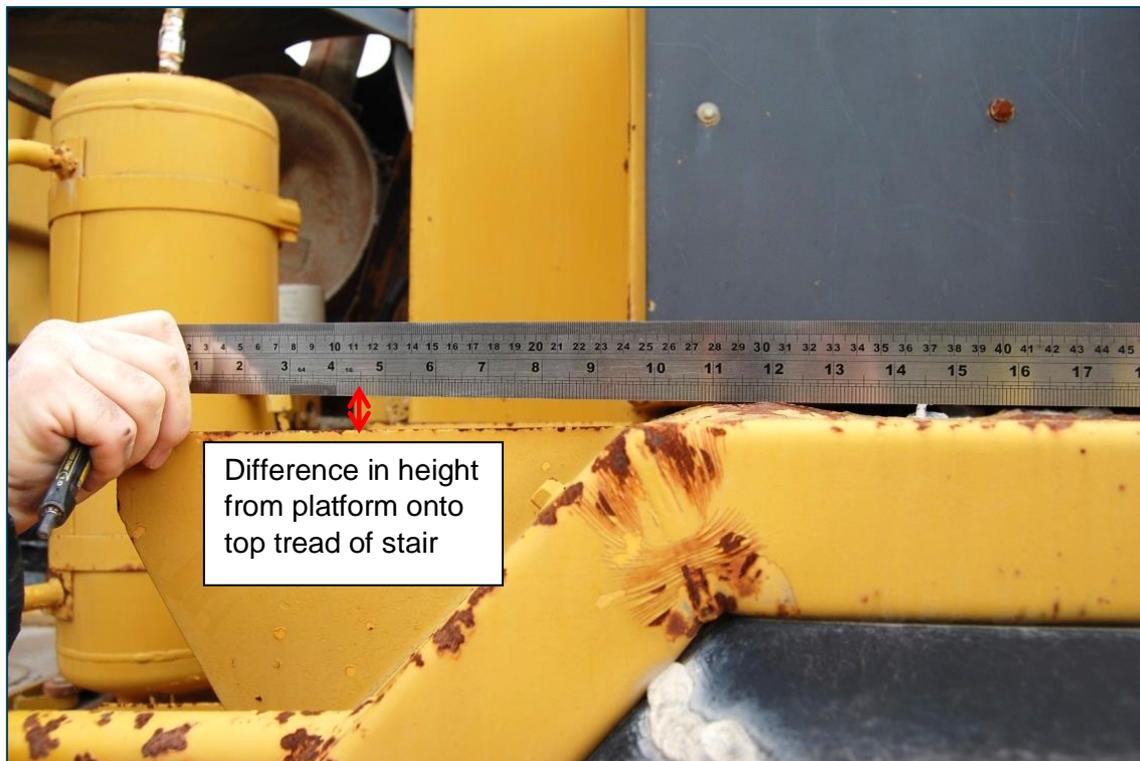
Figure 13: Difference in level from the platform to the top tread of stair.

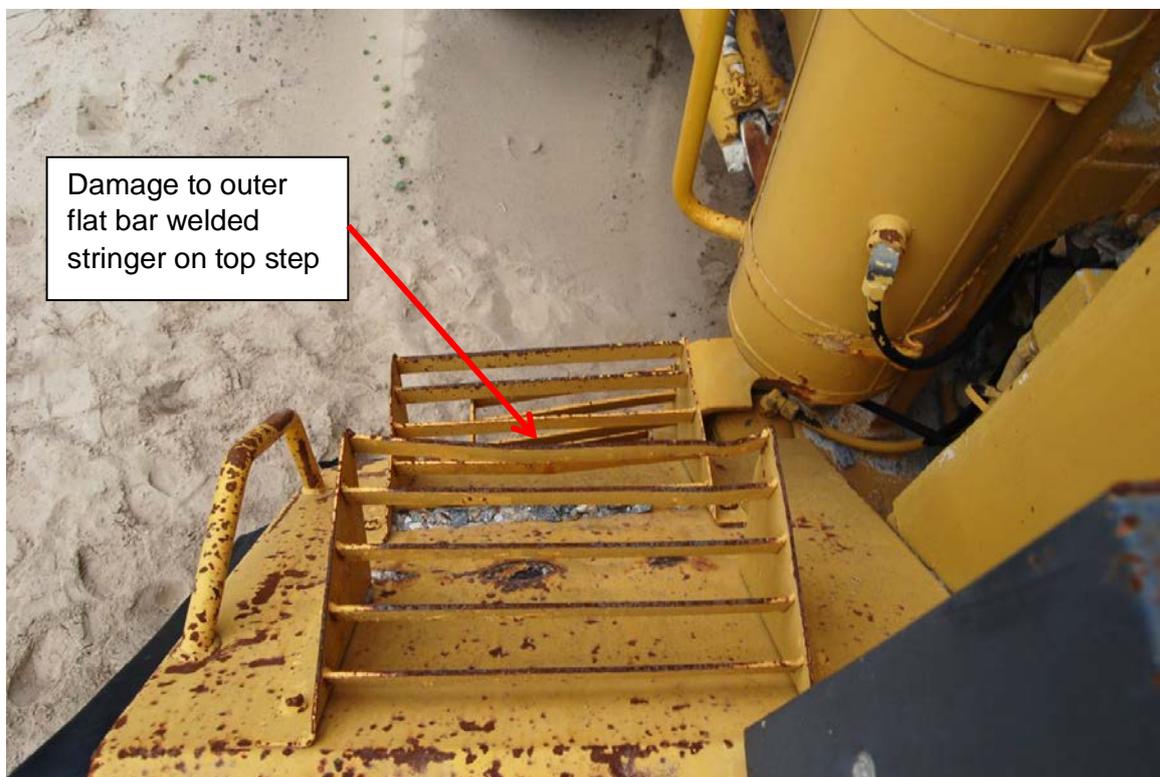
Figure 14: View from the platform of the top step tread to the lower steps. The outer edge flat bar welded stringer on the top stair tread is difficult to see.

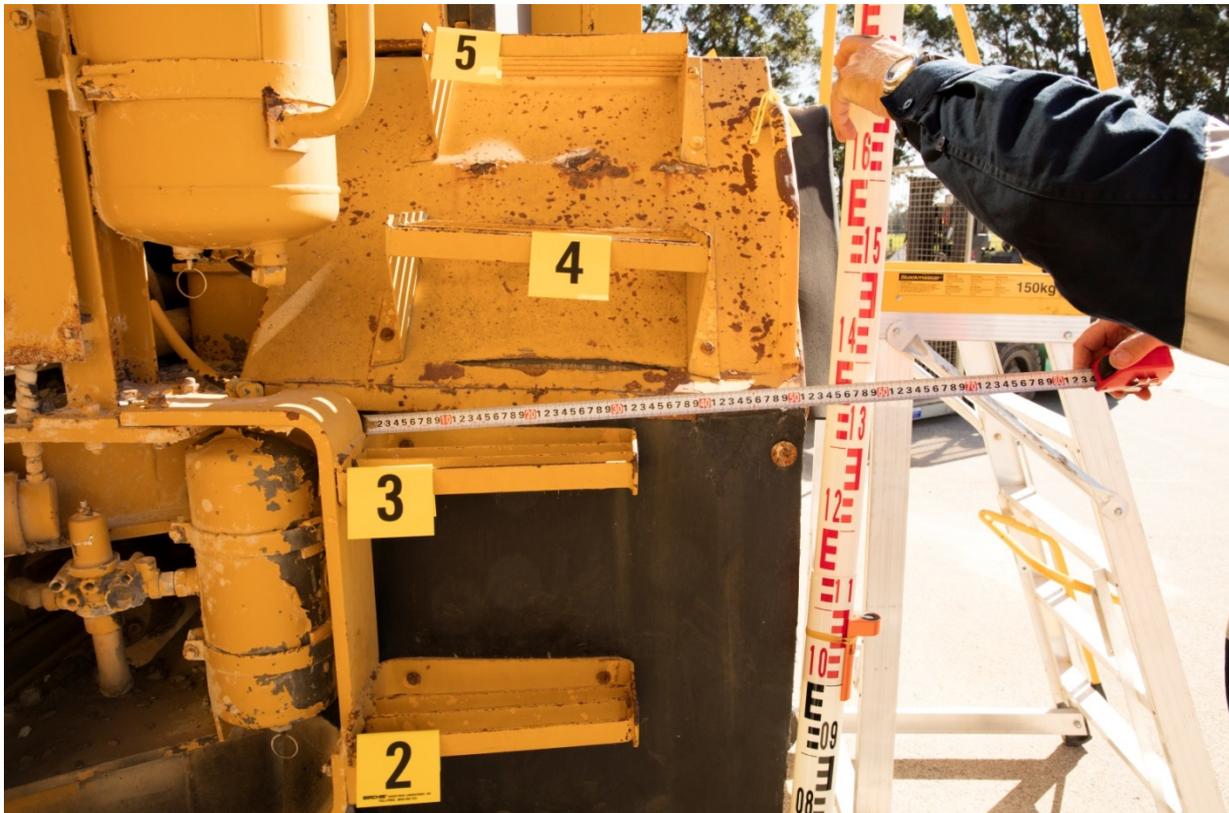
Figure 15: The narrower and offset step ladder rungs (number 2 and 3) leading onto the stair treads (number 4 and 5) on the off- side of the dump truck.

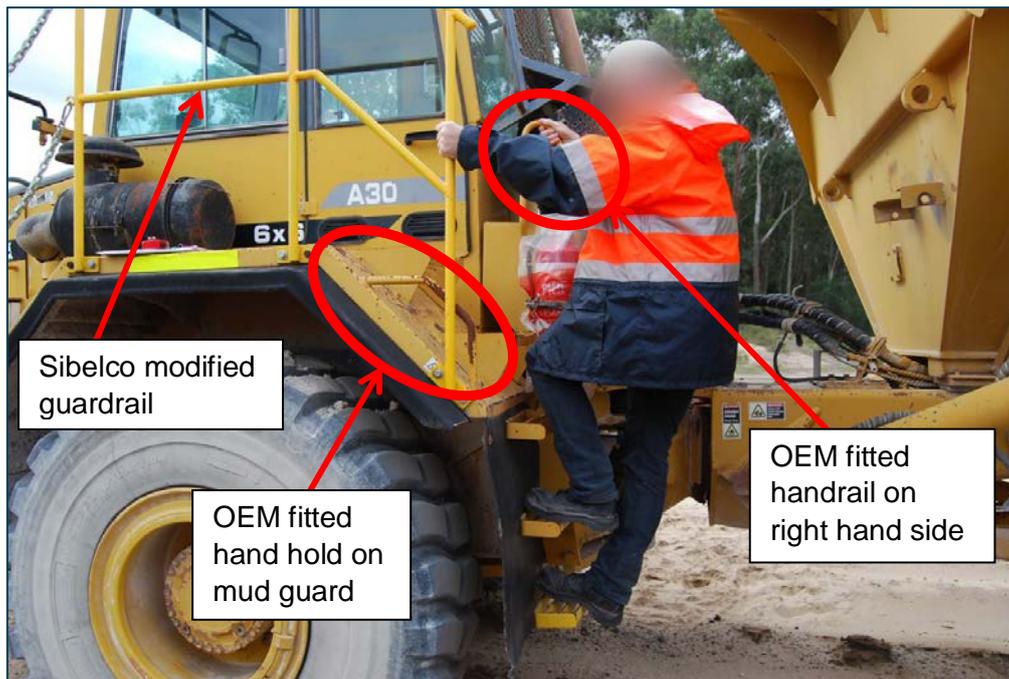
Figure 16: Three points of contact on the driver's side access step using the modified outer perimeter guardrail (left hand) and original equipment manufacturer (OEM) provided hand rail (right hand). The OEM provided hand hold on the mud guard is not intuitively used.

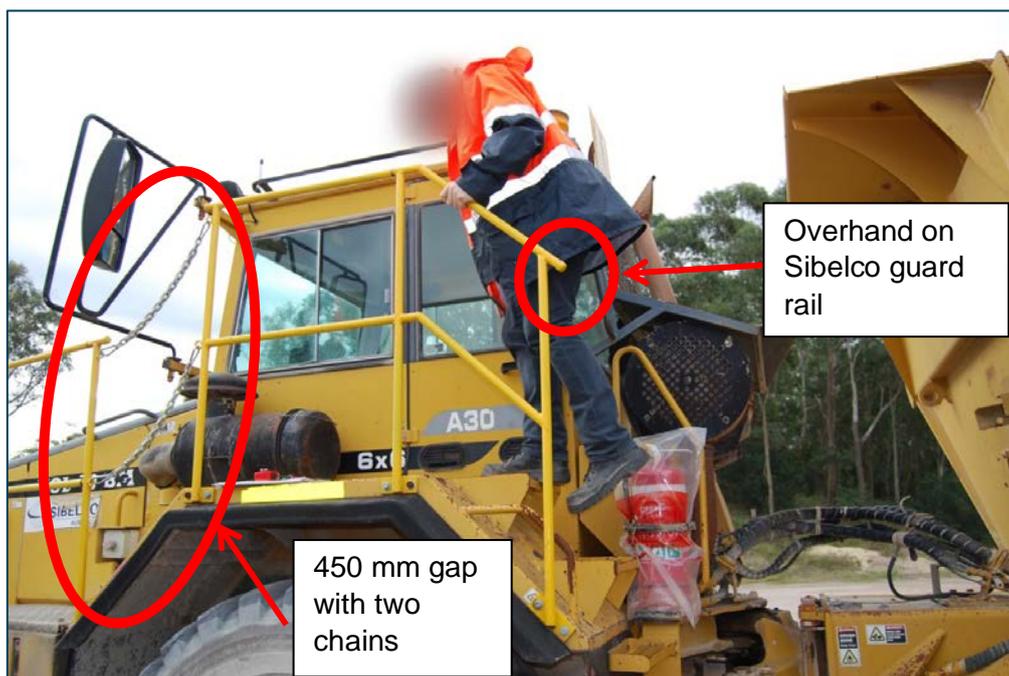
Figure 17: Three points of contact on the top step of the driver side access using the modified outer perimeter guardrail and OEM provided grab rail. A 450 mm gap with two chains is seen in the outer perimeter guardrail underneath the mirror. An overhang is present on the guardrail.

The modified guardrail had a 450 mm gap to allow the driver’s side mirror to swing outwards into the operational position. A chain in a guardrail is not an effective barrier to prevent a fall. Effective three points of contact could not be maintained in the 450 mm gap section of the guardrail.

There was a short overhang at the end of the guardrail that can be a clothing catch point and did not permit continuous three points of contact with the guardrail.
