CAUSAL INVESTIGATION PRELIMINARY REPORT

Workers trapped in shaft winder

Event: Two workers trapped in number 3 shaft winder conveyance mid shaft

Location: Tahmoor Colliery, Tahmoor NSW

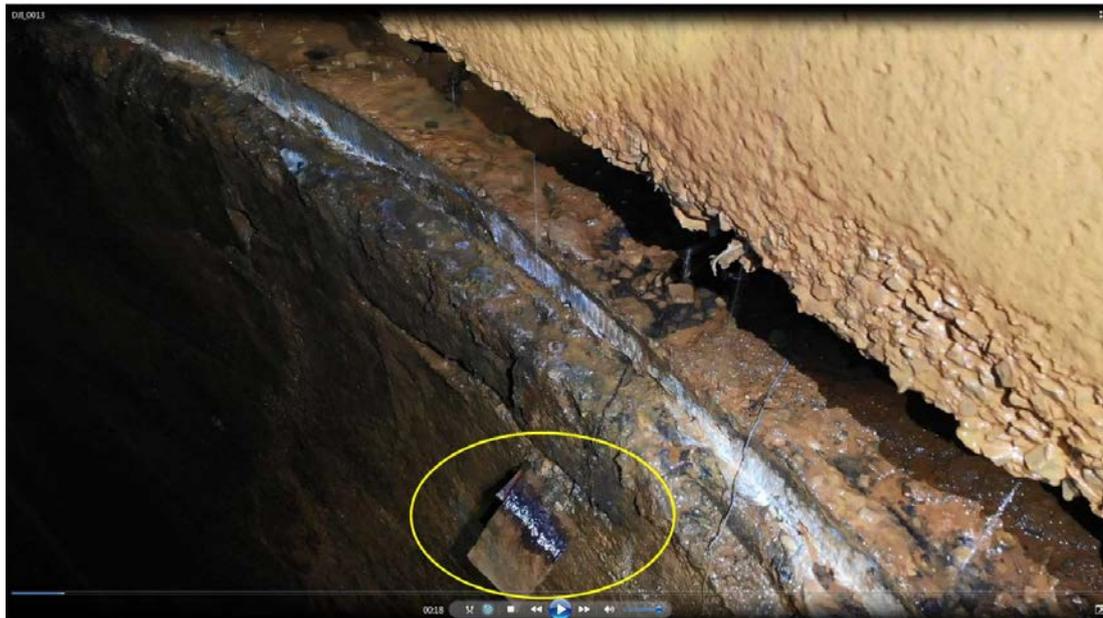
Later analysis of the scene identified significant damage in the shaft. A shaft fixture known as a water ring (guttering on the wall of the shaft used to capture water) was sheared off the sidewall and was wrapped around the counterweight head ropes and guide ropes. Other shaft services related to the water ring were also damaged.

Photograph 2: Water ring bracket damage in shaft. Photograph by Resources Regulator

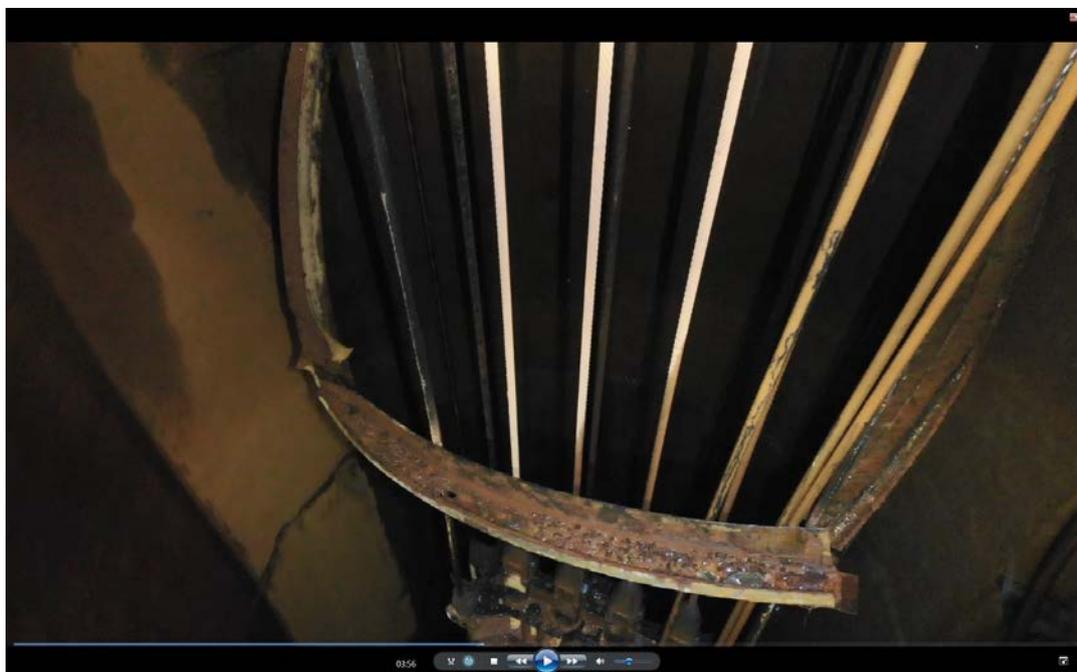
- A fixture known as a water ring (guttering on the wall of the shaft used to capture water) has been sheared off the sidewall and is wrapped around the counterweight head ropes and guide ropes. Other shaft services related to the water ring had also been damaged.

Photograph 3: Water ring wrapped around guide ropes, head ropes and services in shaft. Photograph by Resources Regulator
