CAUSAL INVESTIGATION PRELIMINARY REPORT:

Unintended movement of conveyor boot end unit

- **Incident date:** 29 August 2017
- **Event:** Dangerous incident.
- **Location:** Ulan West Operations, near Mudgee, NSW

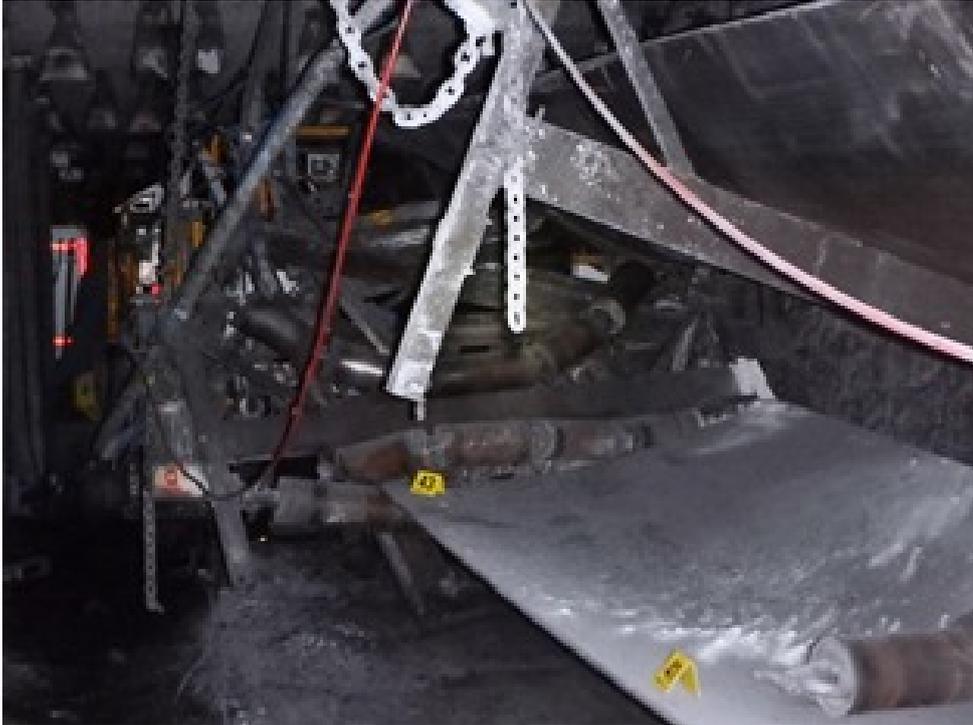
Figure 1: Damaged structure outbye of the tail pulley frame where some of the workers were standing. *Photos supplied by the mine.*

- The boot end was dragged 16.4 m outbye by the belt causing damage to the conveyor structure.

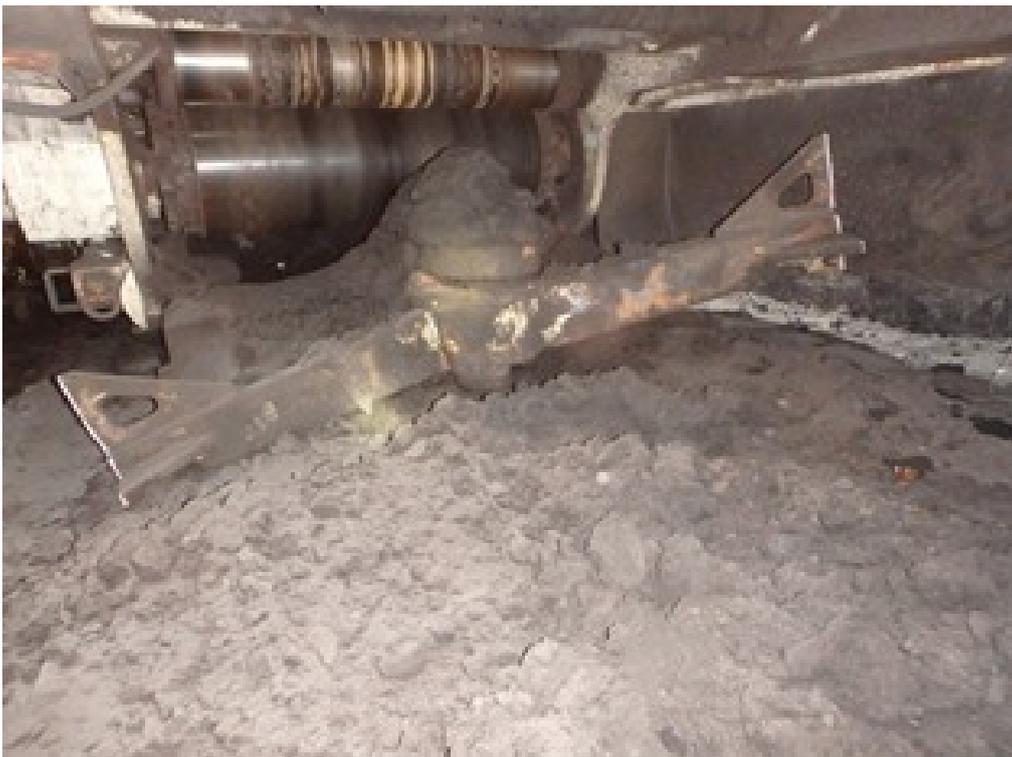
Figure 2: Failed connection hitch looking inbye at the DMU.

- During a scheduled section advance, the FCT/DMU was being advanced when over-tension in the belt caused a failure of the connection hitch between the DMU and the conveyor boot end unit.

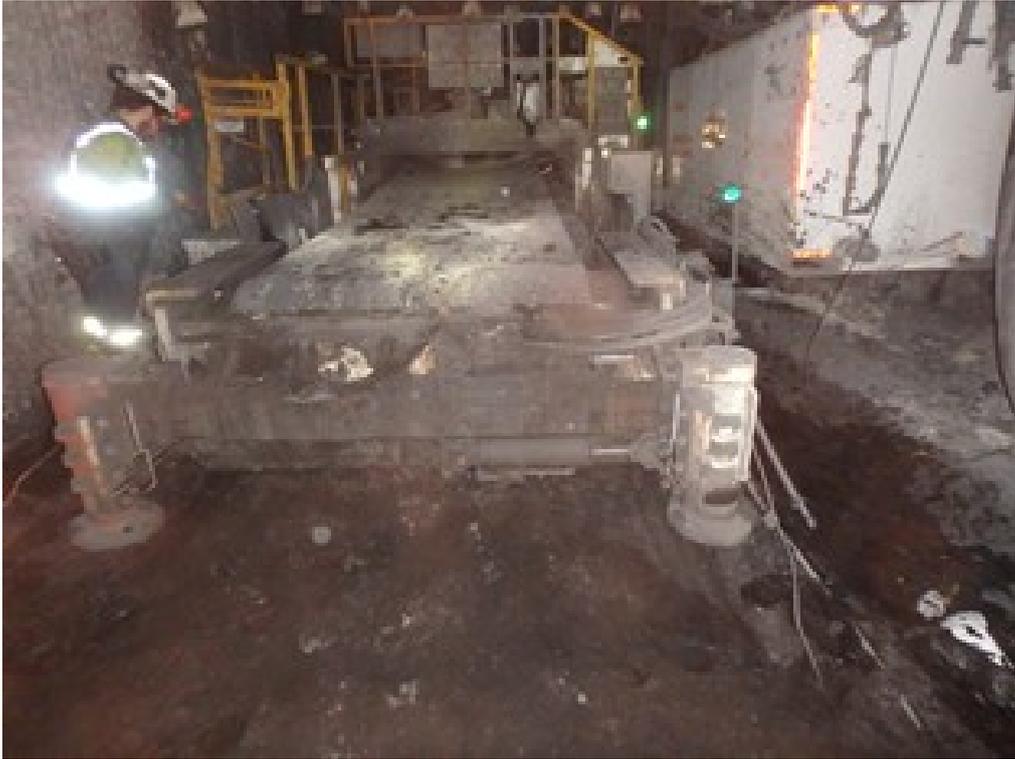
Figure 3: Failed connection hitch where it attaches to the side shift frame on the tail pulley frame.

Note: The distance between the tail pulley frame and the DMU was 16.4 m.
