SAFETY ALERT

INCIDENT	A2P3 - LTI
SUBJECT	Worker Falls in to Post Trench
INCIDENT DATE	2 nd March 2020
BUSINESS UNIT	Higgins – Auckland

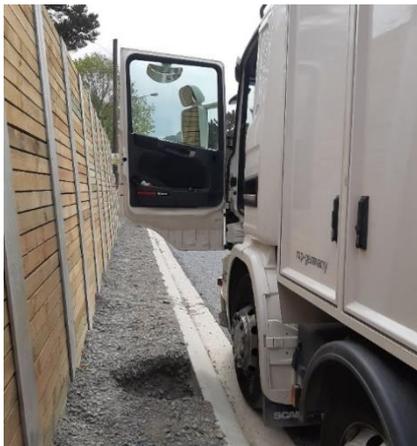
Once the posts locations were marked out by the barrier crew, the hydro-excavation crew decided to start excavation at the southern end of the site and work their way north, to avoid having to pack up their gear each time they moved to the next hole. This left the first hole alone, which was incorrectly excavated about 20m from their starting point. As they worked their way forward the truck ended up positioned with the passenger's door directly above the first hole. When the operator exited the truck after it was parked, he lost his footing on the kerb and fell backwards into the hole hitting his head on the steel H-pile of the retaining wall.

Photos (Re-enactment), Left to Right: The truck parked right beside the post hole; the operator exiting the truck; Position that the operator was found in after the fall;

- The driver of the truck immediately attended to the operator. Ambulance was called for assessment and subsequently the operator taken to the North Shore Hospital for further assessment. Later that night, after completing a CT scan, the operator was released from hospital and referred to his GP. At this stage the injury is treated as LTI. Fortunately, the operator was wearing his hardhat with the chin strap and did not suffer any serious and visible injury.
- All post holes were isolated with a temporary fence.
- All relevant parties were notified and incident investigation commenced.

- Prior to starting work ensure there is an adequate plan in place, and everyone is aware of it. If you are not sure about something, stop and ask your supervisor.
- Identify hazards and appropriate controls before the work starts. If you create a hazard you must manage it.
- Have a risk control plan around excavation. Prevent falls. Clearly identify open excavations. First try to eliminate the risk of falling, then consider use of edge protection or fencing able to take the weight of a falling worker.
