# WEEKLY INCIDENT SUMMARY

Week ending Friday 14 February 2019

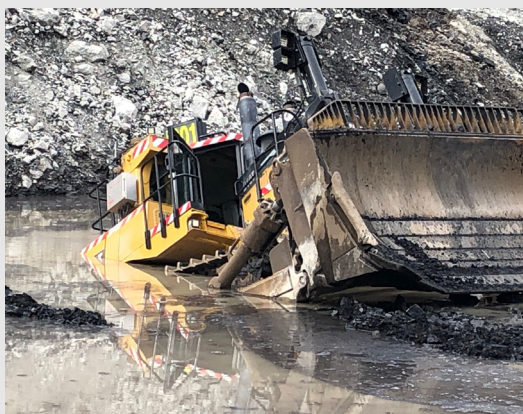
Serious injury  
IncNot0036687  
Open cut coal

An operator’s wrist was cut while trying to get out of a partially submerged, bogged dozer. The operator lost footing, reached out and grabbed the dozer blade. A burr on the blade caused the cut, which needed four stitches.

The area where the incident occurred was very confined, and the site had received about 160 millimetres of rain overnight.

Operators should review and update site procedures for managing bodies of water on site.

Geotechnical consideration should be given to the potential for voids, slumping and subsidence areas to form, particularly following significant rainfall.

The potential for drowning in a submerged vehicle must be considered in such circumstances.

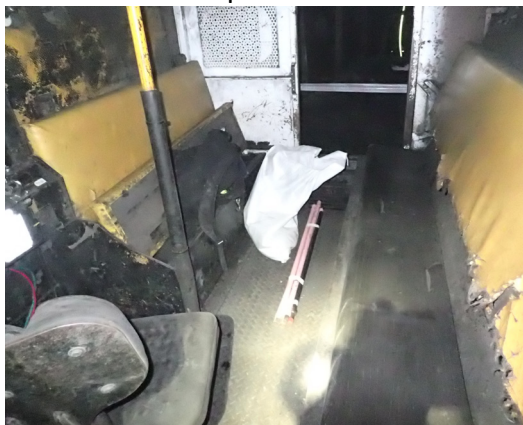
Dangerous incident  
IncNot0036709  
Underground coal

An operator of a diesel man car (DMC) stopped and reportedly activated the dump valve. The operator exited the DMC and turned to switch it off, but it began to roll forward.

The operator activated the intake emergency shut-off valve, but the machine continued to roll downhill.

The DMC travelled about 17 metres to a set of catch points that were closed and travelled a further 23 metres before hitting another parked DMC.

There was no-one in either DMC. The catch points were closed due to excessive build-up of coal and fines.

Operators should review the risks associated with parking machinery on inclines and should implement suitable procedures to eliminate the risk of unattended machines rolling away.

Catch points should be maintained and form part of rail maintenance plans.

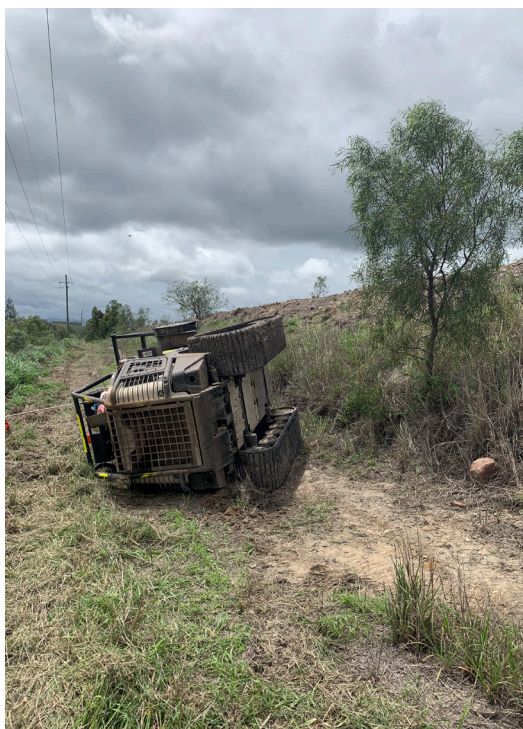
Dangerous incident  
IncNot0036731  
Open cut coal

A skid steer machine fitted with a mulching attachment overturned while it was clearing vegetation on an embankment. The operator was uninjured.

Equipment operators must maintain situational awareness and remain vigilant of the risk of machine rollovers. This incident underpins the importance of wearing seatbelts as a mitigating control. When planning tasks and travel paths, supervisors must consider rollover hazards.
