NZ Safety Alert

28 August 2020

Dump truck reversed into loader

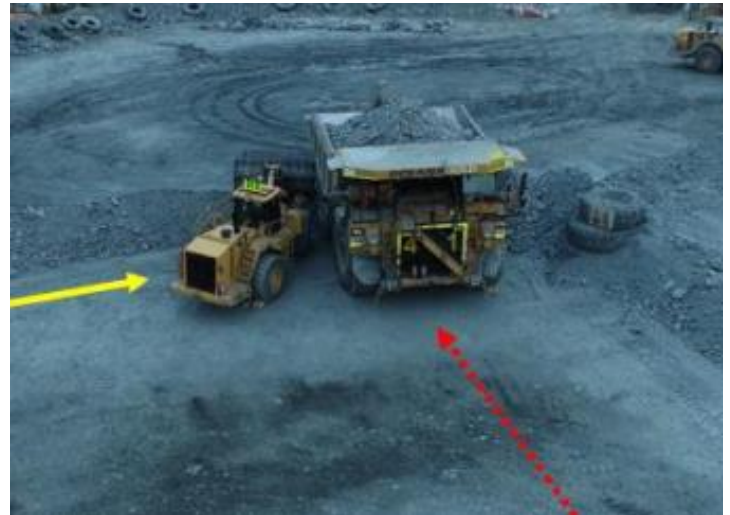
A dump truck was reversing to tip its load over a tip head, while a wheel loader was side-cutting material along the same face to create a windrow (yellow arrow).

The dump truck entered the tip head in a clockwise direction and proceeded to reverse (red arrow). As he was doing so he impacted the loader bucket with the rear right side of the dump truck tray.

There were no radio communications between the dump truck and the loader prior to or during the incident.

No injuries were sustained by either operator and there was negligible damage to either piece of mobile equipment.

1. Work areas are set up in such a way to avoid unnecessary interaction of mobile equipment and other vehicles.
2. Traffic Management Plans include appropriate controls to avoid collision potential such as separation, exclusion zones, positive two-way communication, safe traffic flow, adequate visibility etc.
3. You consider collision avoidance technology where appropriate.
