04 April 2022

#### FATAL ACCIDENT

#### Three workers fell from scaffold

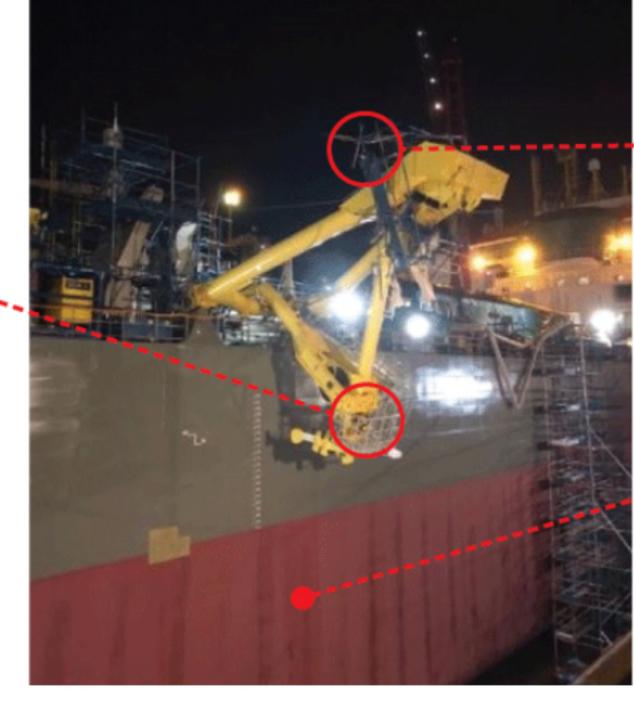
Scene of the accident.

On 28 March 2022, three workers were on a scaffold erected around a gantry structure of a dredging vessel at a shipyard. The gantry structure suddenly dropped causing part of the scaffold to be flung to the dock bottom. Two of the workers fell about 20 metres to their death, while the third worker survived with minor injuries as he managed to cling onto a part of the structure.

Damaged scaffold

Dredging vessel

Gantry structure

which dropped

- Structural integrity: Assess the integrity of a structure before erecting scaffolding around the structure. If the scaffolding is attached to the structure, the structure must be able to withstand the additional loading due to the weight of the scaffold, workers, tools and equipment.

- Movable parts locked in place: Lockout all movable structure parts securely to ensure there is no movement while work is in progress. Check the locking mechanism(s) regularly to confirm they are in good working condition.

- Structural support: Put in place additional supports to prevent movement of the structure.
- Fall Prevention Plan (FPP): Develop and implement a FPP and Permit-To-Work system, for all hazardous work at height. Where possible, provide independent and secure anchor points or lifelines and train workers to anchor themselves at all times when working at height.

- Safe Work Procedure (SWP): Establish and implement a SWP for carrying out work on the gantry structure and provide supervision to ensure workers follow the SWP. The SWP should include checks on structure integrity and locking mechanism(s).
