NZ Safety Alert

Worker injured during maintenance

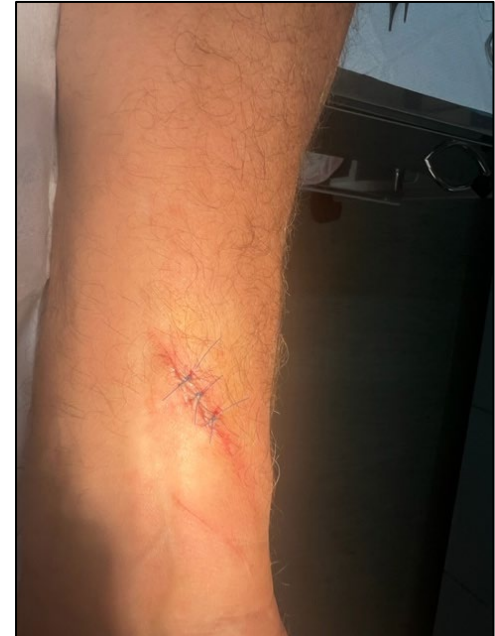
A quarry worker was replacing a broken blow bar on a crusher. The worker removed the old bars and proceeded to clean up the wear surfaces using a grinder and wire brush.

While wiping down the area he accidentally sliced his left wrist on a sharp spur that had formed on the centre wedge. The spur could have formed through the movement of the broken bar during operation of the crusher. The cut required stitches.

While it was known that the centre bar was broken, the workers continued to operate the crusher monitoring and regularly tightening the centre wedge.

1. You check all wear surfaces prior to maintenance to identify hazards such as sharp spurs and remove them before conducting maintenance.
2. Maintenance is prioritised once broken or worn parts are identified.
3. Regular workplace inspections are conducted to identify broken or damaged equipment which should be repaired or replaced immediately where practical.
