## Serious injury

**Incident date:** 21 April 2018

**Event:** Serious injury at open cut coal mine

**Location:** Maules Creek Mine, Maules Creek NSW

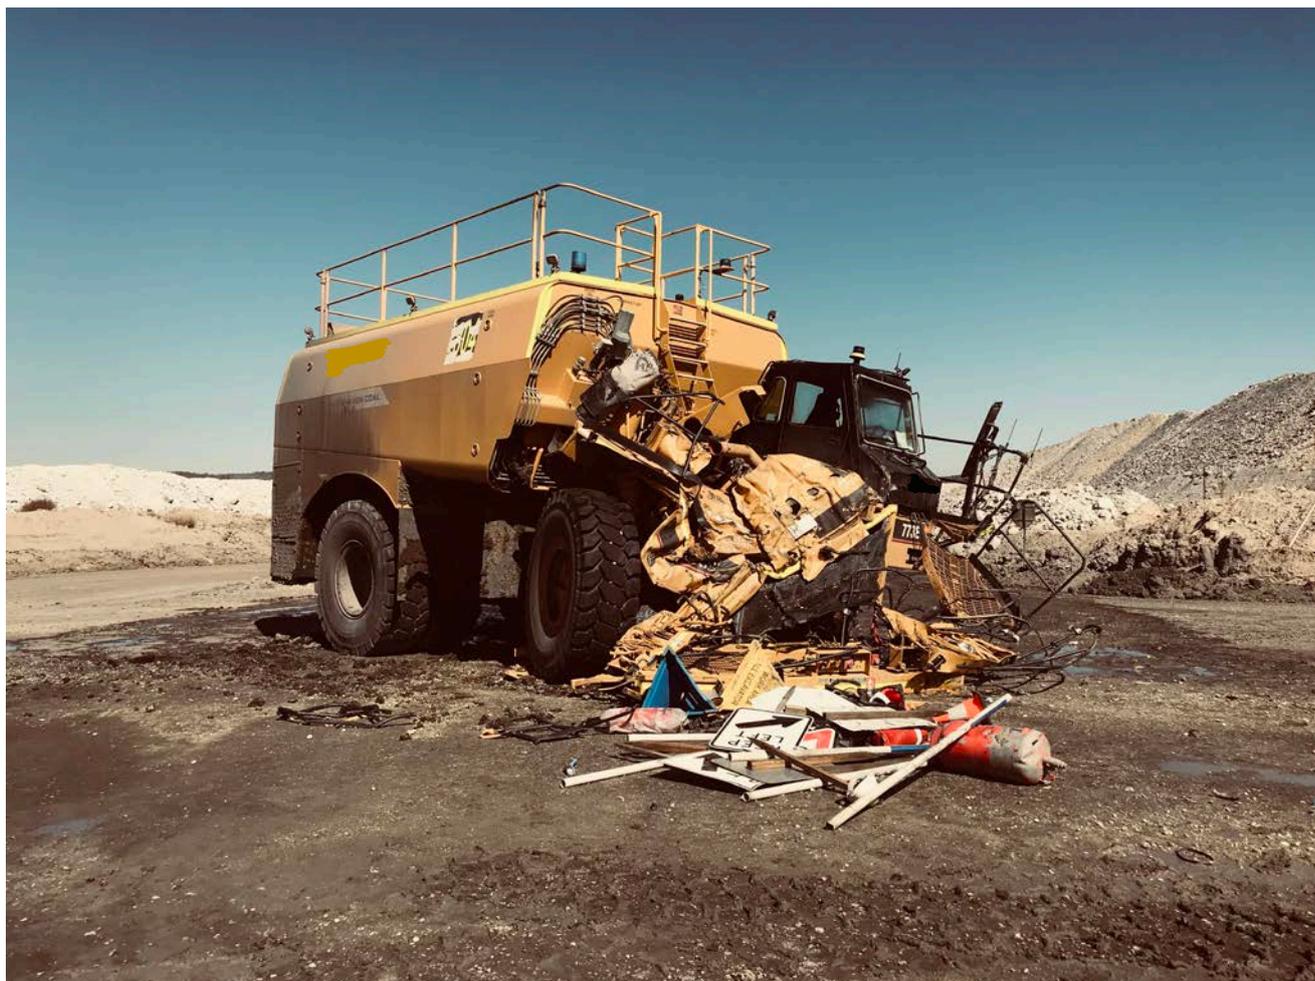
**Photograph 1: Damaged front end of service truck.**

The service truck suffered substantial damage. The operator, a labour-hire worker, aged 43, received serious injuries in the collision. The injured worker was transported by helicopter to hospital where he underwent medical treatment.

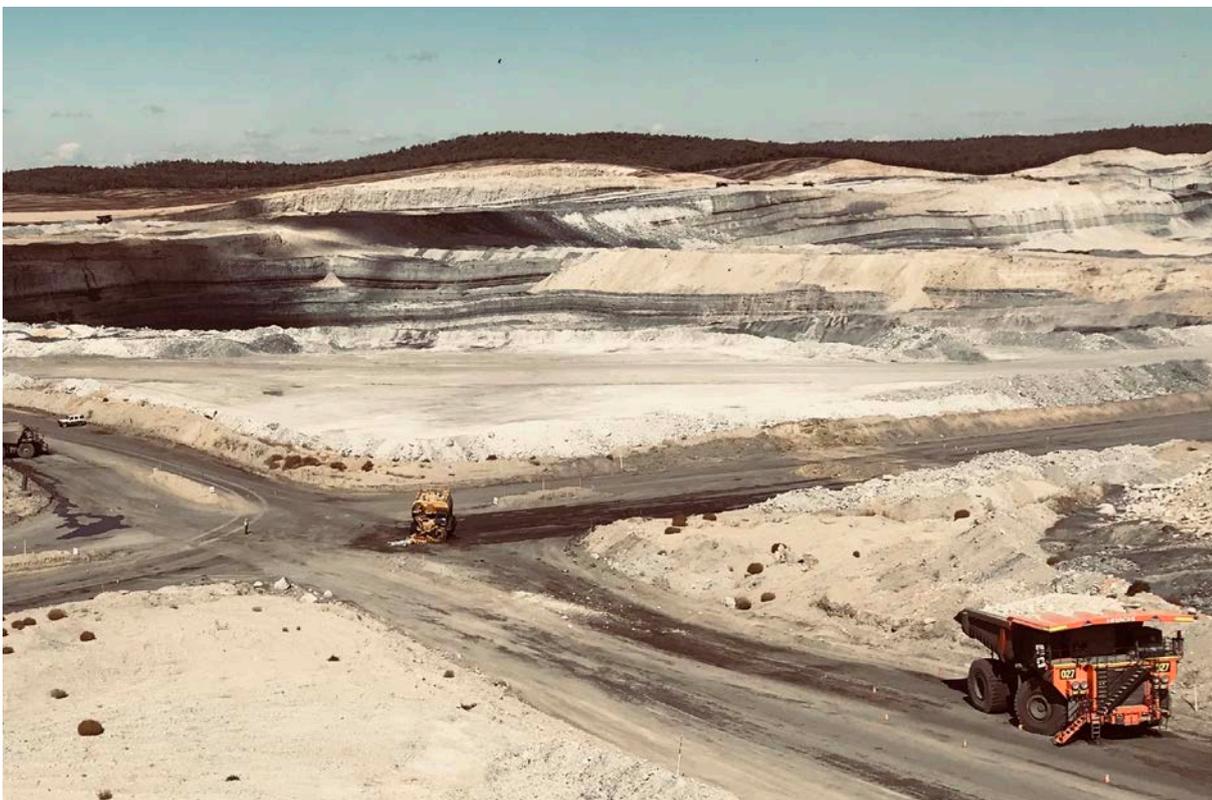
At about 7.58 am on 21 April 2018, a Caterpillar 773 service truck and a fully-laden Hitachi EH5000 haul truck collided at a major four-way intersection on the mine haul road.

**Photograph 2: Four-way haul road intersection showing trucks involved in the collision.**

Preliminary enquiries indicate that the intersection traffic control rules were changed one day prior to the incident.

Mine operators must ensure that mobile plant is safe to operate and provide adequate information about the plant and road conditions for the safe operation of the plant. All changes to traffic control rules must be adequately risk assessed and effectively communicated to workers.
