SAFETY ALERT

Worker sucked into auxiliary fan ventilation tube

This safety alert provides safety advice for the NSW mining industry.

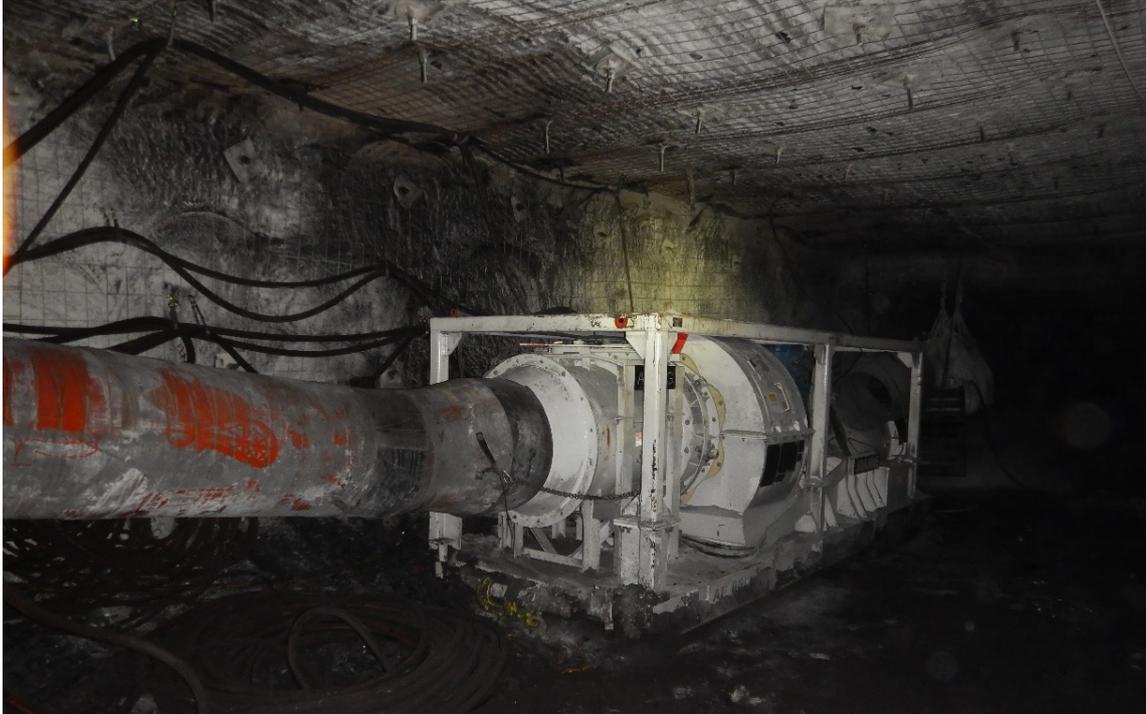
Figure 1 The auxiliary fan

The auxiliary fans specifications were 200KW and 26 m³/s open circuit capacity. The variable inlet vanes (VIVs) were set at 13 m³/s and 618 millimetre diameter tubes were being used.

The photographs in figures 1 and 2 show the auxiliary fan and the ventilation ducting involved with the incident.

- Mine operators should review their auxiliary fan operational risk assessments (for each type of auxiliary fan in use at each site) and ensure the risks to health and safety for people working in close proximity to ventilation ducts during installation, operation, maintenance and repair are identified and controlled. The specific hazard identified with this incident (workers being drawn into or against the ventilation ducting) should be considered.
- With the review of risk assessments above, mine operators should implement controls in accordance with the hierarchy of control measures as required in clauses 35 and 36 of the Work Health and Safety Regulation 2017.
- The operating range of auxiliary fans (i.e. VIV settings) should be determined through modelling and testing, to ensure the ventilation tubes can be added into the circuit without

risk to workers being sucked into or onto the end of a tube while clearing gas, dust, and diesel exhaust pollutants, as well as preventing recirculation.

- The location used for monitoring ventilation performance and hence determining any change in fan operational parameters must be formalised in the mine's safety management system (for example – the procedure for auxiliary fan operations).
- Safe standing zones and the detailed process steps to safely install ventilation ducting should be formalised and documented in the mine's safety management system.
- The relevant sections of the workforce should be trained and refreshed (at a frequency determined by the mine) in the safe operation of auxiliary fans on site – including the installation/extending of ducting.

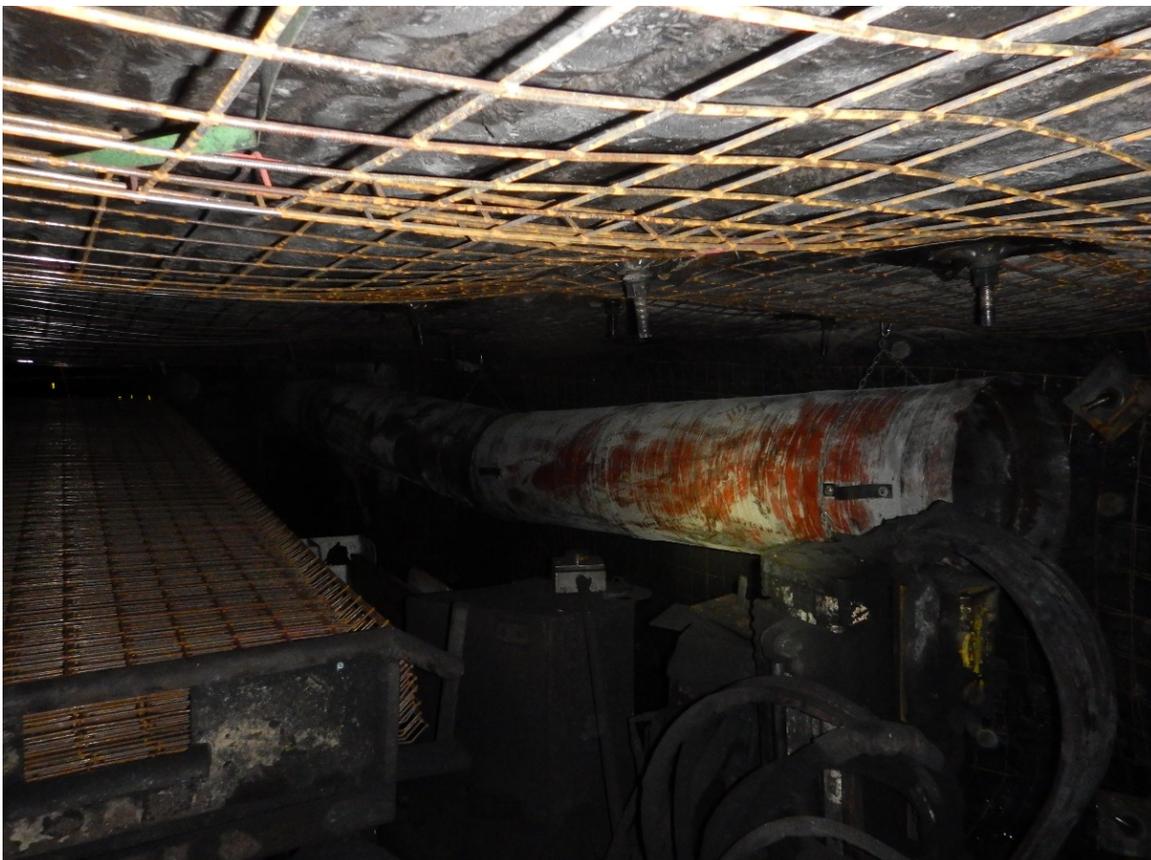
Figure 2 The incident scene at the mine face

A mine worker, who was installing an auxiliary fan ventilation tube, was sucked into the end of the tube. Due to the pressure around his neck, the worker briefly lost consciousness.

The ventilation duct run was about 90 metres to the face. The run included a 90 degree elbow and an inline T-piece with an end cap fitted.
