NZ Safety Alert

6 November 2020

Worker falls while exiting loader

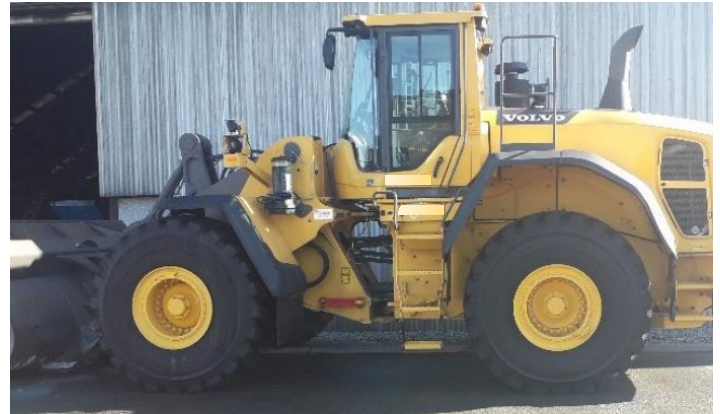
While washing his loader, a worker was standing on the step near the back of the cab washing the roof. Once he finished, he climbed backwards down the ladder (with 3 points of contact). When he got to the bottom step his foot slipped and he fell backwards, hitting his head.

When exiting mobile plant, the operator's visibility is reduced while descending the ladder, limiting the ability to detect hazards which may cause slips.

Most of the body weight is supported by the feet moving down the ladder and the hands play a crucial role in fall prevention. If the hands are unable to maintain contact with the ladder, a slip will probably result in a fall.

1. Workers take caution when ascending and descending to and from cabs of mobile equipment, including maintaining 3 points of contact at all times.
2. Pre-start checks on mobile equipment include checking of rungs to ensure they are securely attached to the ladder.
3. Designated parking areas are free of hazardous conditions such as uneven terrain, rocks, slippery surfaces, and contaminants on the ladders.
