NCTIR Safety Alert

Working with Powered Systems. Hand tool powered mixing of grouts.

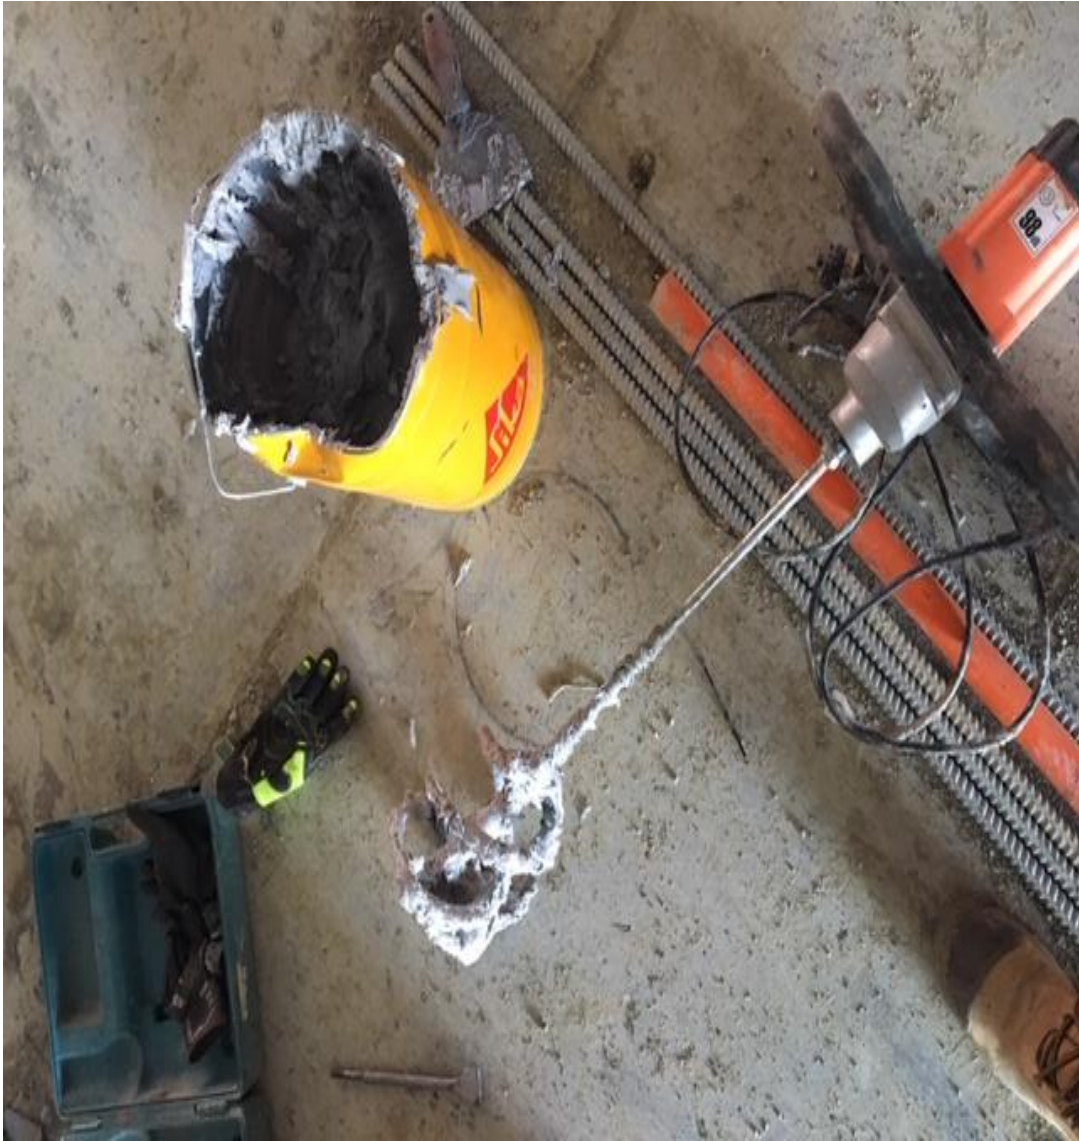
While mixing some epoxy grout a worker has reached down to the bucket handle to stop the bucket turning.

His sleeve has been grabbed by the mixing spindle and broken his lower arm.

The job was being undertaken by two workers holding the mixing drill and using their feet to hold the bucket.

As a result of this incident NCTIR requires:

- That all activities involving hand held powered mixing be stopped until a safe methodology can be found.
- That prevention options will be reviewed and alternative approaches developed by the 18th of September
- Until the 18th of September if a project urgently requires grout mixing that the site management team develop a safe process with their safety advisor and submit for approval to the Project Director.
- Please submit photo's or contact Safety Advisor of methods that would remove the danger of entanglement with moving parts
- We need your help to make all workers safe
