## **Plant on Plant Interaction – High Potential Incident**

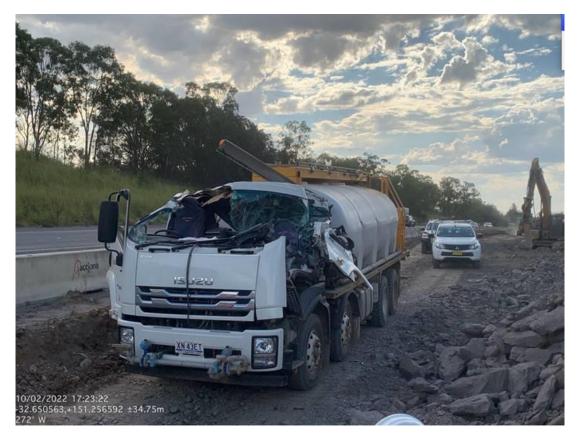
A 36T excavator was working adjacent to a haul road. When the water cart drove past, the excavator operator has swung on the blind side and the bucket of the excavator struck the cab of the water cart, displacing the roof of the vehicle cabin.

- Exclusion zones need to encompass all operational movements of the mobile plant i.e., machine at full reach, use of attachments and the counterweight of the machines.

- In this incident, the excavator was operating next to a haul road. Where possible, this
  scenario should be avoided through appropriate traffic management plans. If this cannot
  be achieved due to site constraints, other controls should be implemented such as
  closing the route, or having a person manage traffic movements in coordination with
  plant operators.

- When passing plant is entering exclusion zones, always communicate with the plant operator and confirm plant is isolated before passing or entering the exclusion zone.

- Machine operators are required to lower attachments to the ground and confirm the mobile plant is positively isolated (e.g., blue light on) before confirming access into the exclusion zone.

- Slew locks should be considered for use on excavators where there is potential for excavators to slew into operational roadways.
