# NZ Safety Alert

20 October 2023

## Uncontrolled movement of dump truck

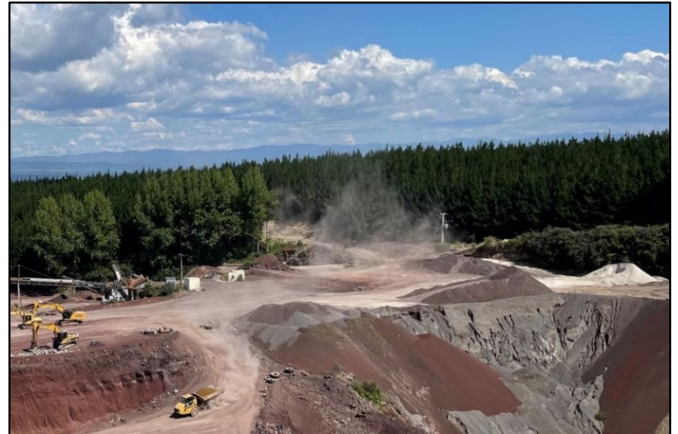
While constructing a new haul road layout in a section of a quarry, two tracks were formed adjacent to each, one slightly higher than the other.

As a dump truck reversed it was not clear which track to use and the driver had one side of the truck wheels on the high track and the other on the lower track.

As the driver reversed, the uneven nature of the track caused the dump truck to tilt until the driver pulled forward to stabilise it.

1. When designing traffic movement and haul road systems, you consider the users of the road and what you are trying to achieve from the modified haul road layout.
2. You clearly communicate changes in traffic management and haul road layout to all workers and users of the haul roads.
3. Identify uneven surfaces and haul roads, and level them, remove them from use or restrict access for mobile equipment.
