## INCIDENT ALERT

LOCATION:	TRANSPORT	ALERT STATUS:	Normal
ACTIVITY:	TRANSPORT / DELIVERY	DATE ISSUED:	11/09/2017 17:34:34
SUB ACTIVITY:	PRODUCT DELIVERY	INCIDENT No:	01469

#### Failure to use vehicle braking systems results in arctic rolling out of control

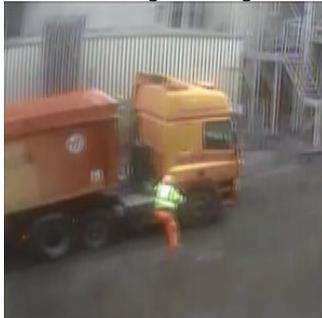
He climbed on to the back of the tractor unit and connected the compressed air lines, which released the trailer brakes. After a few seconds, he realised that the vehicle was moving and jumped clear. He then ran alongside the vehicle attempting to disconnect the air to reapply the brakes, this action put him at great risk. The vehicle picked up speed, jack knifed and collided with a site building.

Driver jumps away from vehicle

- Following training and safe systems of work.
- Not being tempted to rush and cut corners.
- Applying the park brakes to the tractor and trailer unit.

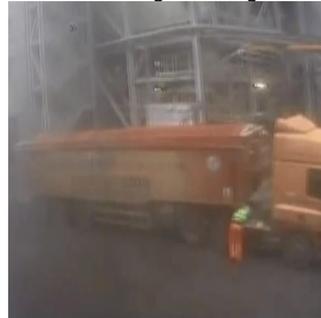
Driver runs alongside vehicle

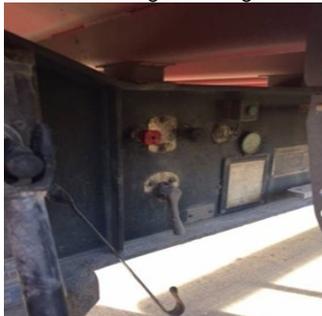
- The driver had been attending the site for around a year and was familiar with the process and had received full training.
- A safe system of work was in place.
- The driver had been re-inducted only a few days before.
- The park brake on the trailer had not been activated by the driver.
- The handbrake on the tractor unit had not been applied by the driver.
- The audible and visual alarms were in working order. These are activated when the handbrake is not applied and the cab door is opened.

Trailer brake

**The trailer brake (red button) should be pulled out when the trailer is left unattended or detached from the trailer.**

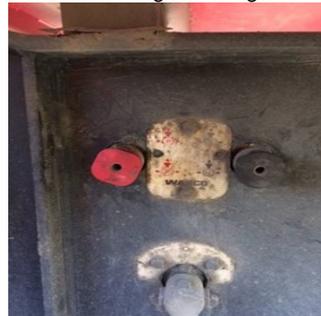
Red button should be pulled out
