## **NZ Safety Alert**

21 February 2020

MinEx

## Fire destroys excavator

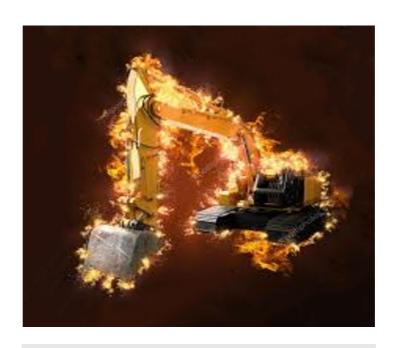
A loader driver at a quarry spotted smoke coming from the engine bay of a 50 tonne excavator.

The fire could not be extinguished, and the excavator was destroyed.

While still under investigation, it is believed a fuel or hydraulic fluid leak onto hot components had started the fire.

- 1. All mobile plant is maintained in accordance with Original Equipment Manufacturer requirements.
- 2. Mobile equipment pre-start checks include signs of leaks and other potential fire hazards.
- 3. You have clear procedures for how to deal with fires on mobile equipment including provision of appropriate firefighting equipment.
- 4. Workers are trained and assessed as competent to deal with fires on plant and equipment.
